## STRUCTURES INSPECTION FIELD REPORT

BR. DEPT. NO.  
**P-02-003**

## SPECIAL MEMBER INSPECTION

CITY/TOWN <b>PAXTON</b>	8-STRUCTURE NO. <b>P02003-6UX-MUN-BRI</b>	11-Kilo. POINT <b>000.306</b>	90-ROUTINE INSP. DATE <b>Dec 3, 2021</b>	93*-SPEC. MEMB. INSP. DATE <b>Jun 21, 2023</b>
07-FACILITY CARRIED <b>HWY BLACK HILL R</b>	MEMORIAL NAME/LOCAL NAME	27-YR BUILT <b>1850</b>	106-YR REBUILT <b>1929</b>	*YR REHAB'D (NON 106) <b>0000</b>
06-FEATURES INTERSECTED <b>WATER TURKEY HILL BROOK</b>	26-FUNCTIONAL CLASS <b>Rural Local</b>	DIST. BRIDGE INSPECTION ENGINEER <b>M. Azizi</b>		
43-STRUCTURE TYPE <b>101 : Concrete Slab</b>	22-OWNER <b>Town Agency</b>	21-MAINTAINER <b>Town Agency</b>	TEAM LEADER <b>R. Rogers</b>	
107-DECK TYPE <b>1 : Concrete Cast-in-Place</b>	WEATHER <b>sunny</b>	TEMP. (air) <b>17°C</b>	TEAM MEMBERS <b>B. SANTEUFEMIO</b>

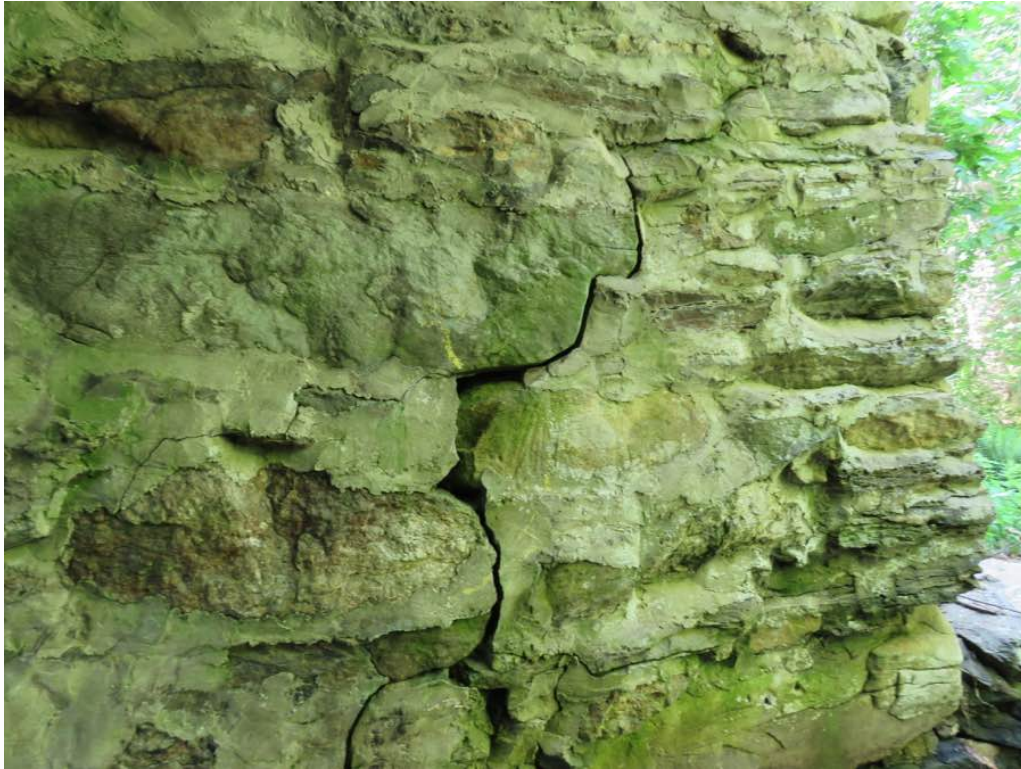
West end, 1" wide full height settlement crack with up to 4' penetration into the crack and up to 1" outward displacement. **See photos 1-2-3.**

Photo 1: South breastwall, West end.

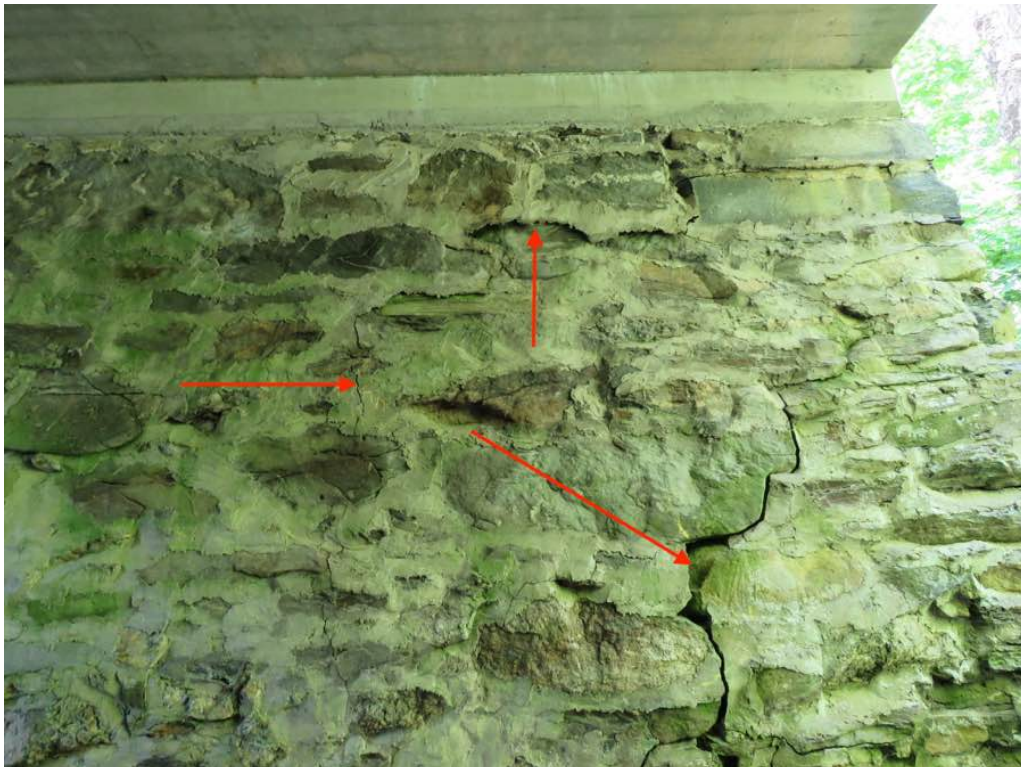
Photo 2: South breastwall, West end showing cracks.

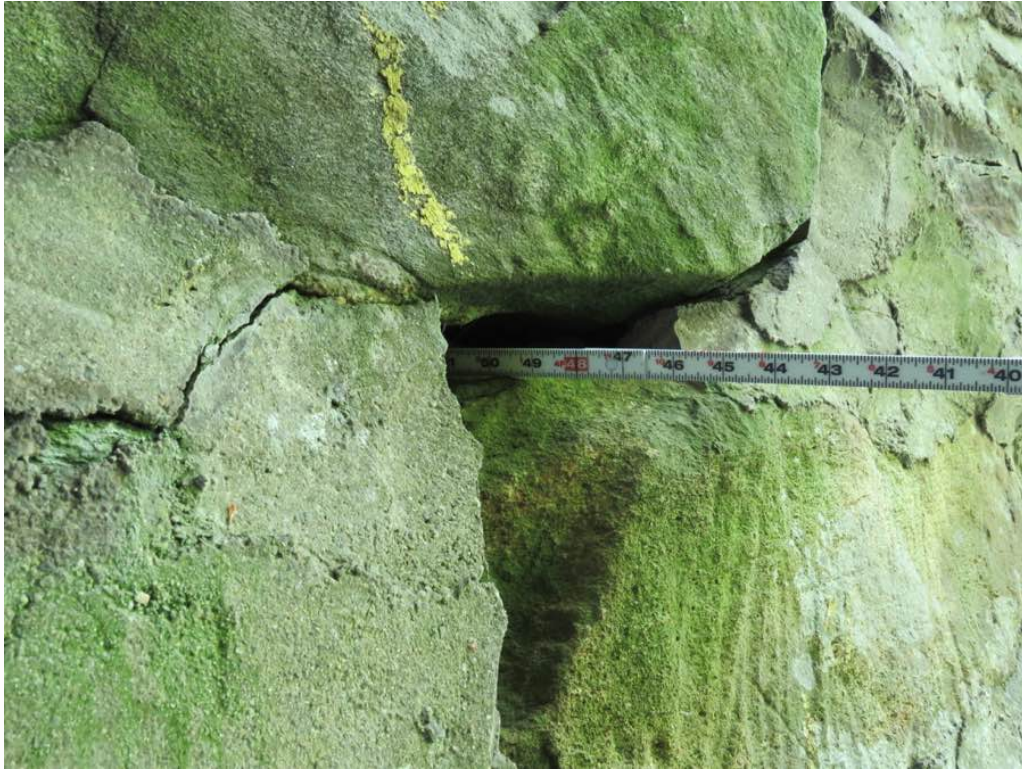
**Photo 3:** South breastwall, West end showing penetration.

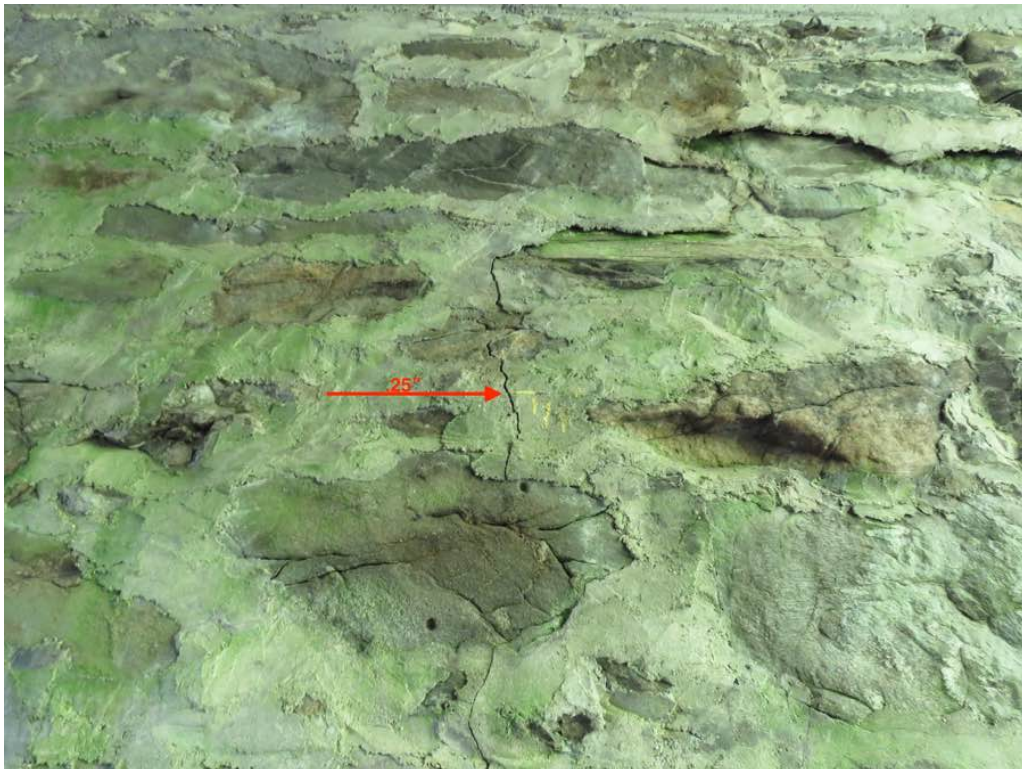
At 5' east of aforementioned crack, 0.25" wide full height settlement crack extending diagonally to top west corner. **See photo 4.**

**Photo 4:** South breastwall, West end East of west crack.

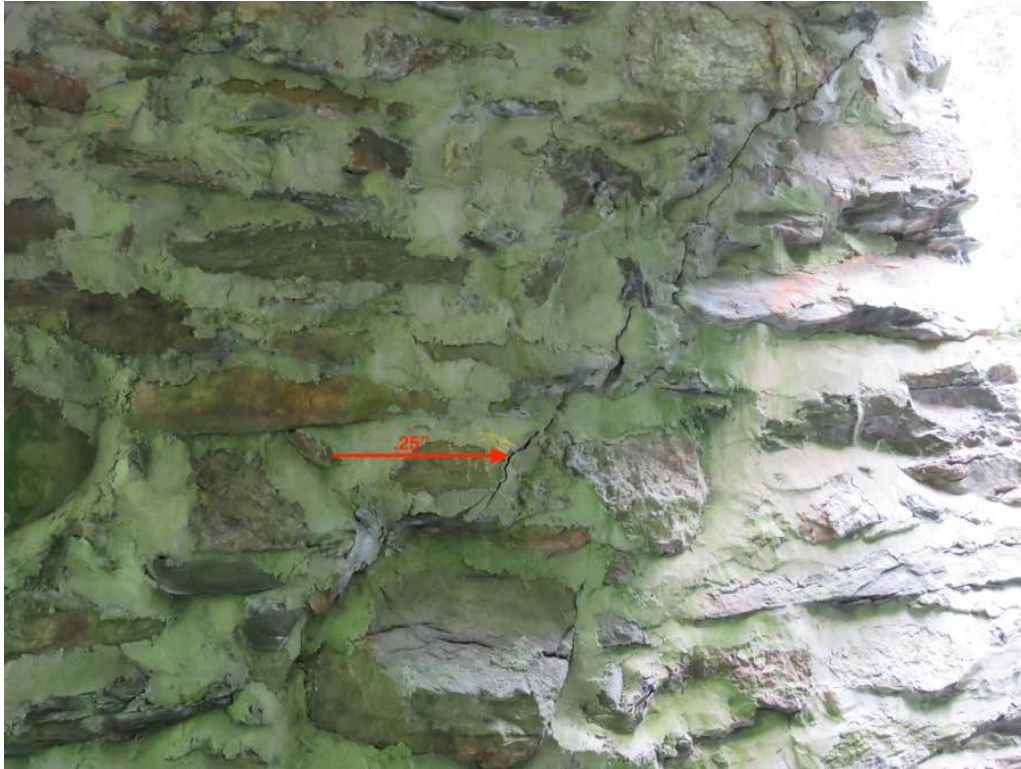
East end, full height diagonal crack up to 0.25" wide. **See photo 7.**

Photo 7: North breastwall, East end.

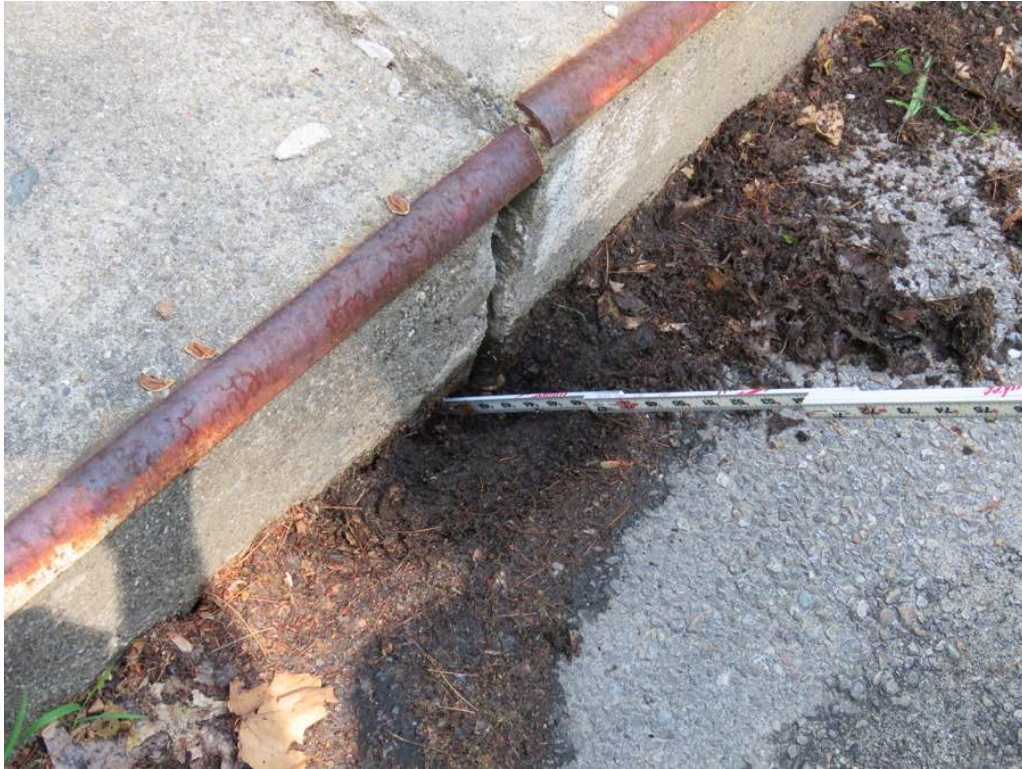
There is a hole at the interface of the wearing surface and the wingwall at the joint. **See photos 12-13.**

Photo 13: Hole at the joint interface.

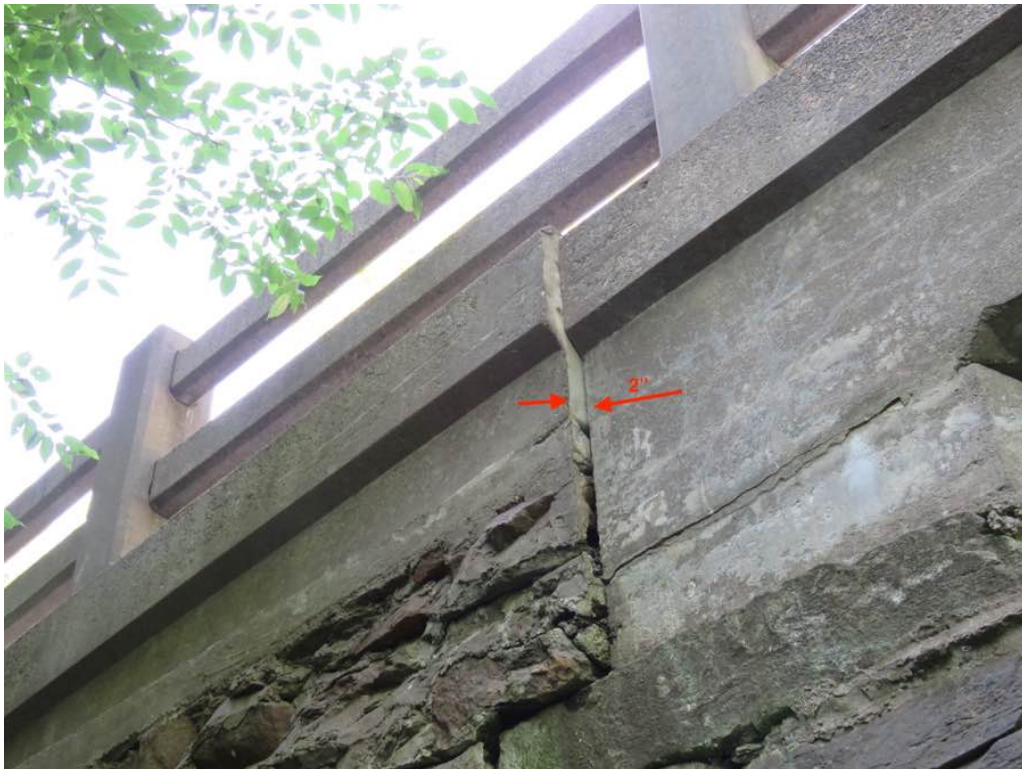
Wingwall top has 2" of outward displacement (measured at the concrete rail base) and a full height crack along the pointing. **See photo 14.**

Photo 14: Southeast wingwall displacement.

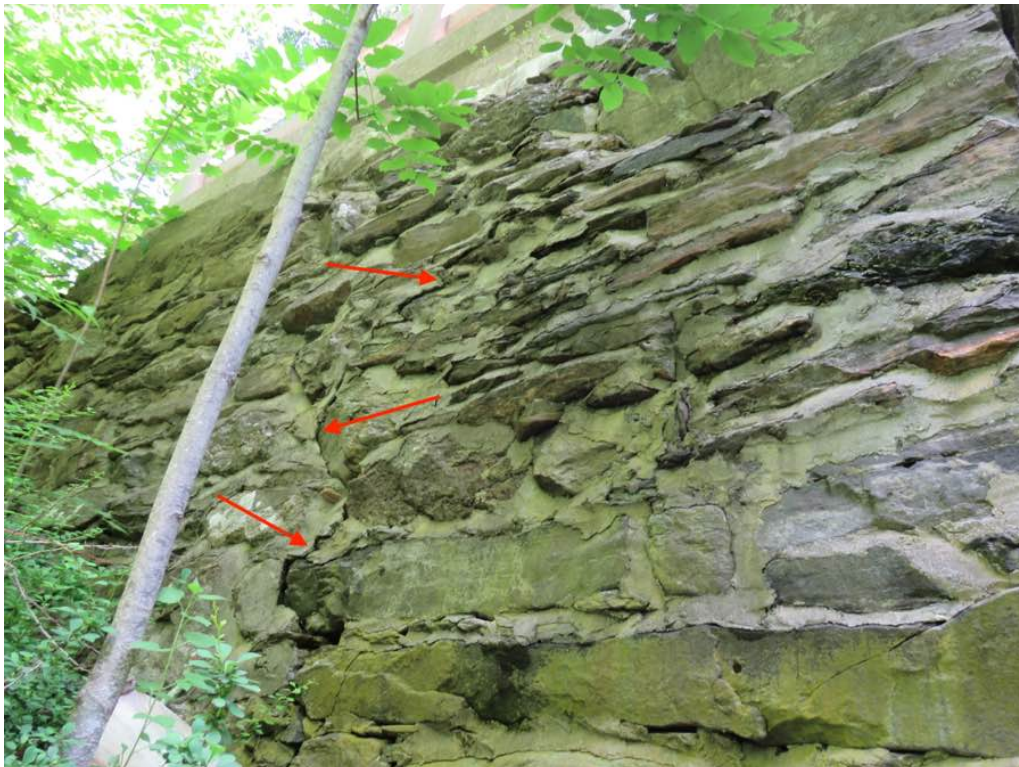
Outward displacement, 1" with full height settlement crack (at pointing/stone interface). **See photo 16.**

Photo 16: Northwest wingwall cracks.

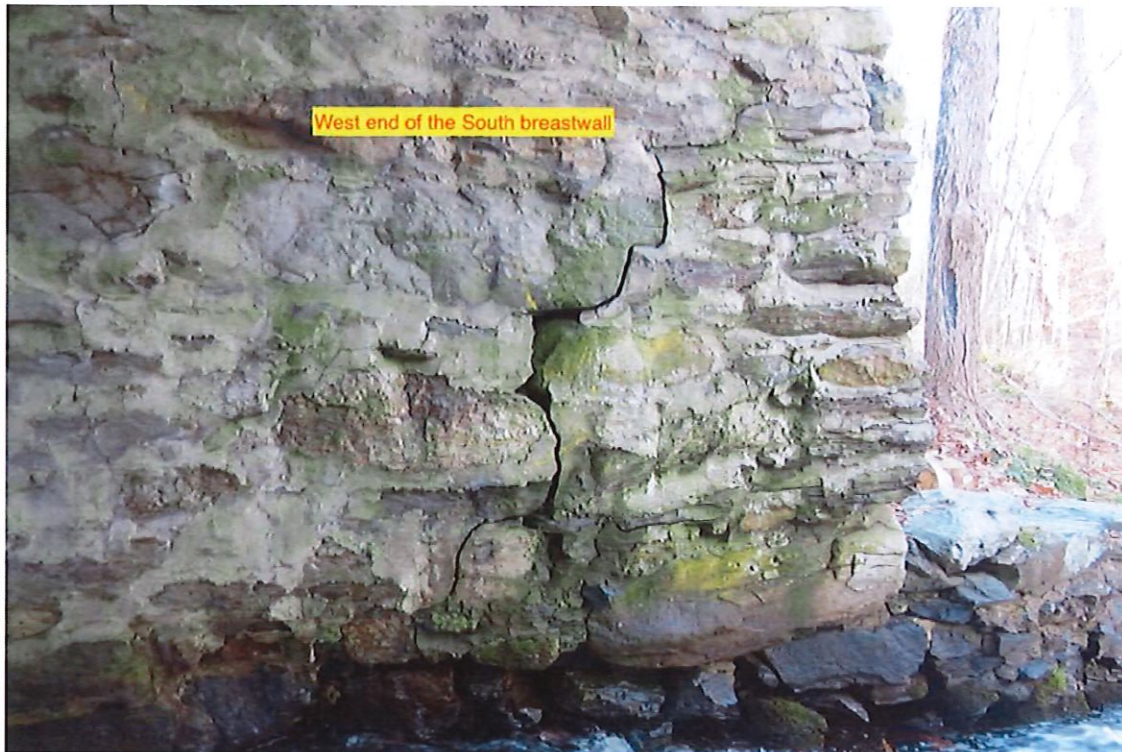
**Photo 1:** Crack to the West end of the South breastwall.

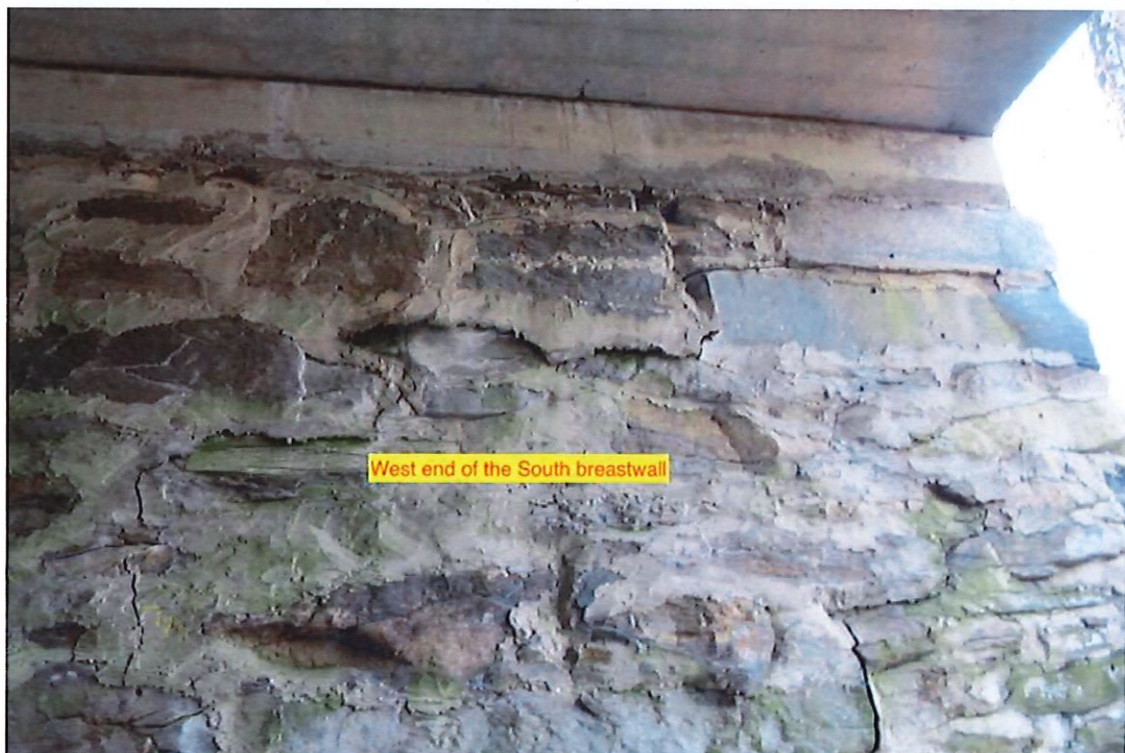
**Photo 2:** Cracking at the top of the South breastwall at the West end.

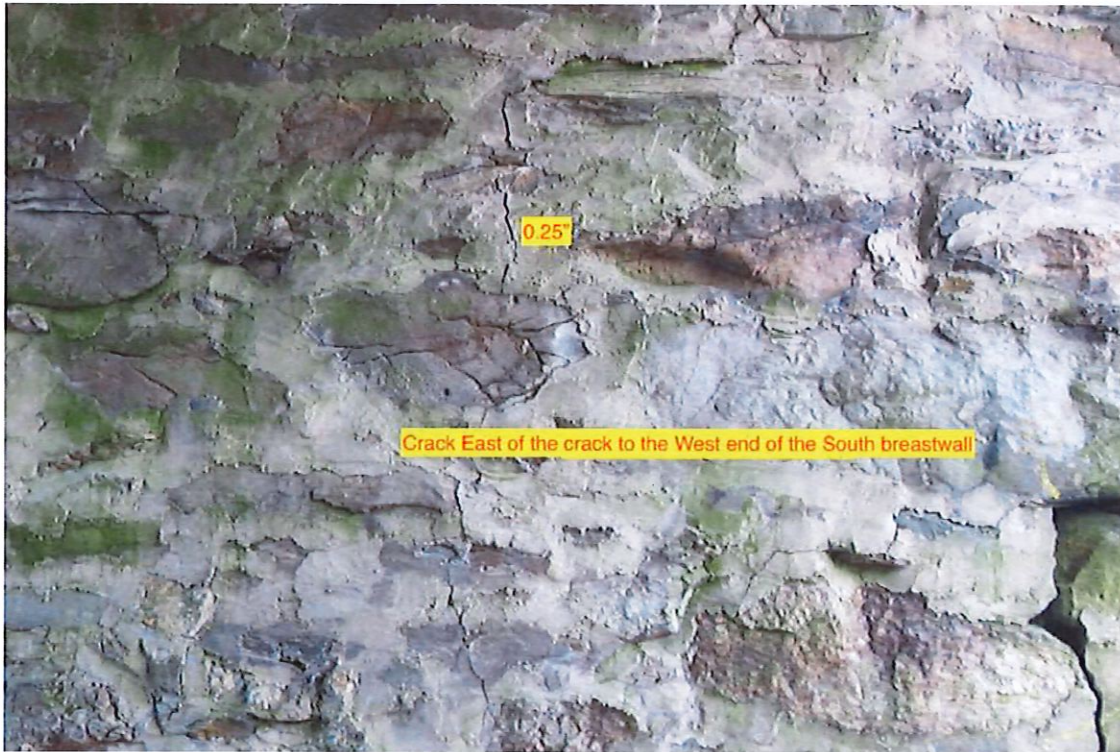
**Photo 3: Crack to the South breastwall.**

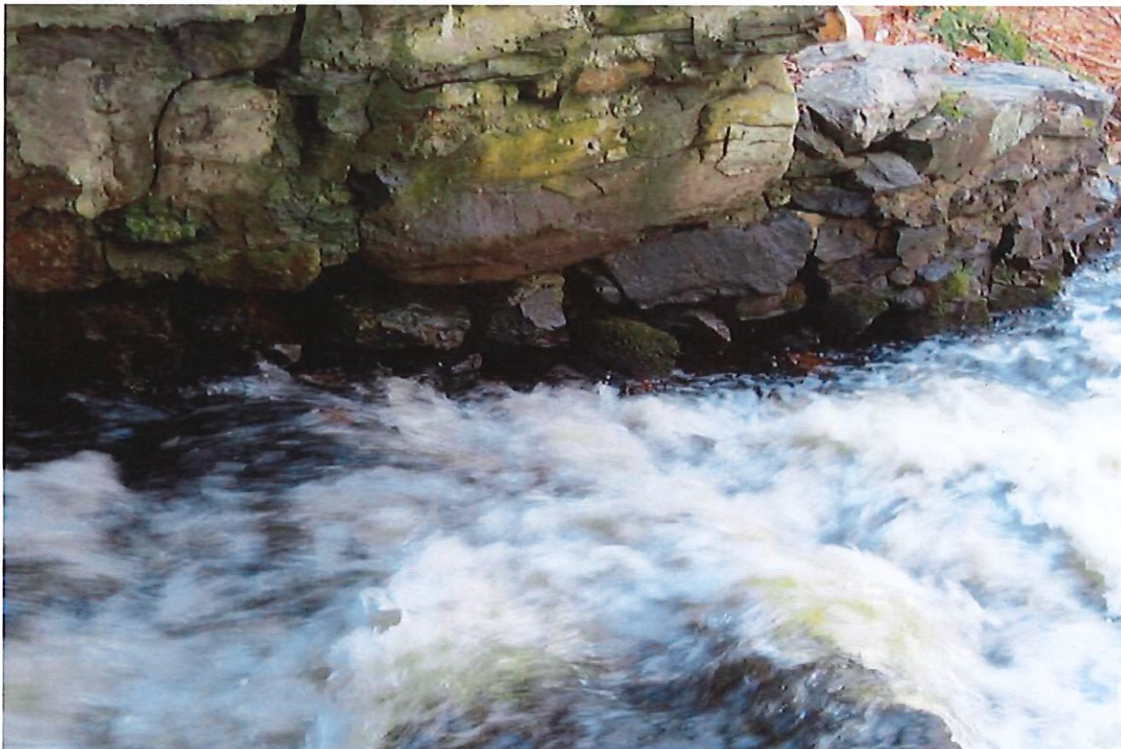
**Photo 4: South breastwall voids to the bottom at the West end.**

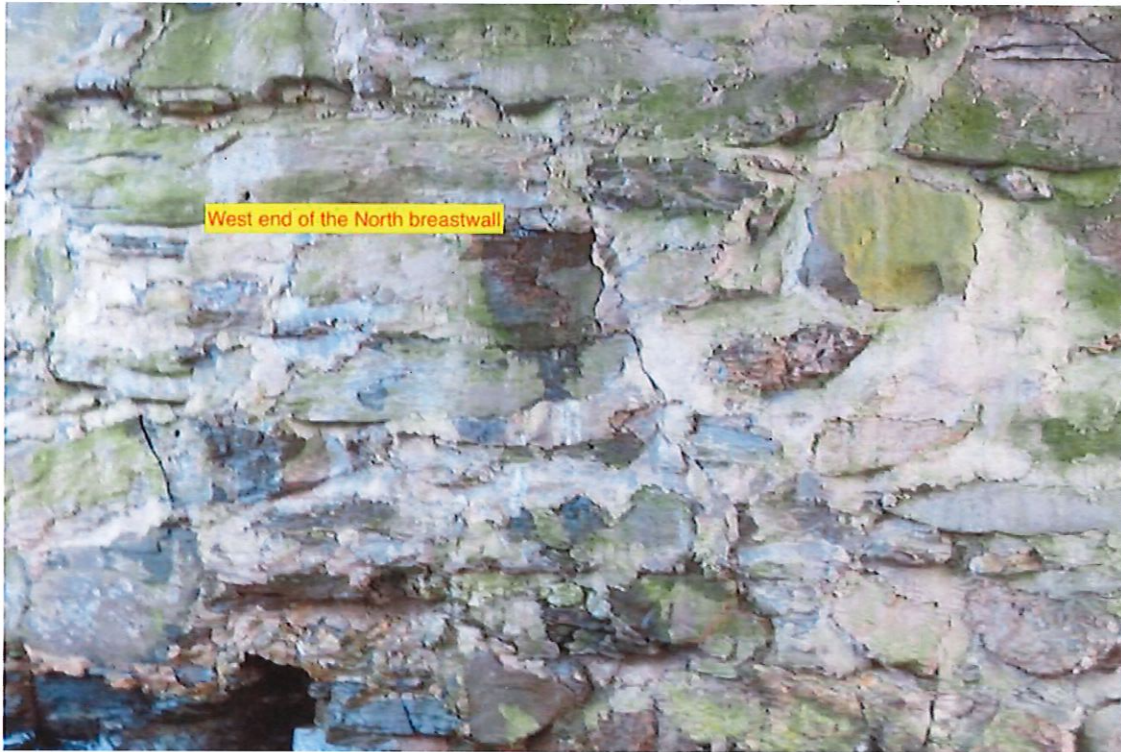
- West end; 0.18 inch wide full height settlement crack. **See photo #5.**
- West end bottom; one dislodged stone with no evident settlement/displacement of the overlying stones.
- West end last 3 foot bottom; up to 2 feet of penetration.
- East end; full height diagonal crack up to 0.25 inch wide. **See photo #6.**
- East end near bottom; two cracked stones.

**Photo 5: Crack to the West end of the North breastwall.**

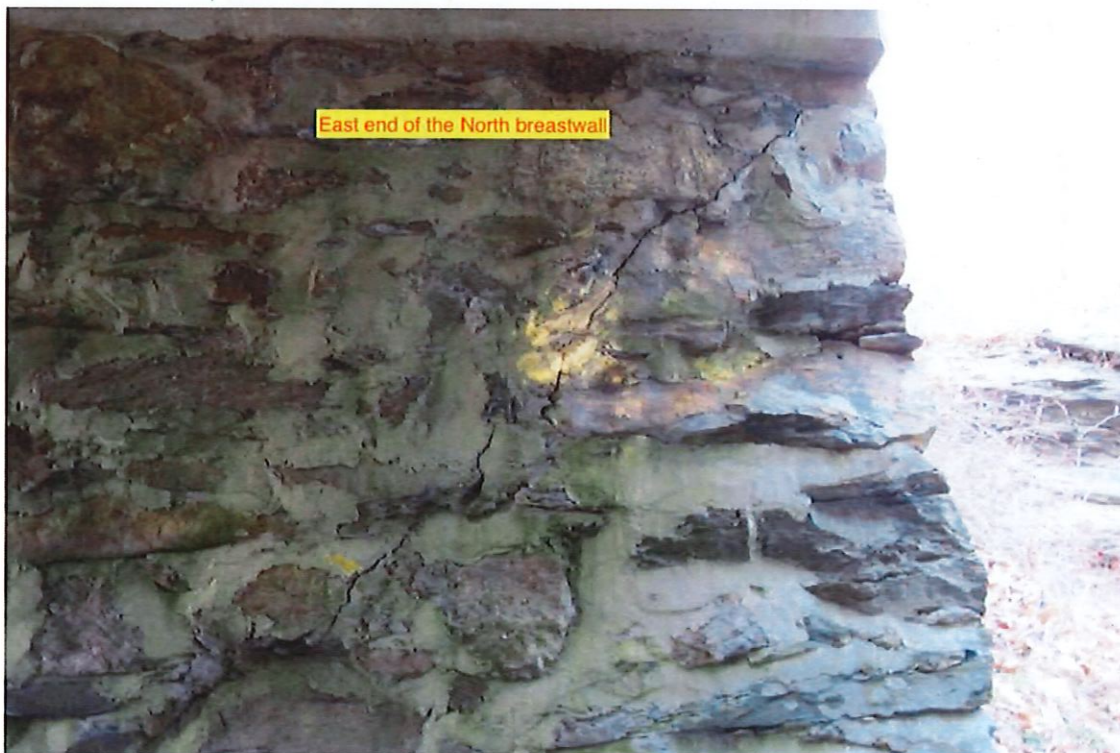
**Photo 6: Crack to the East end of the North breastwall.**

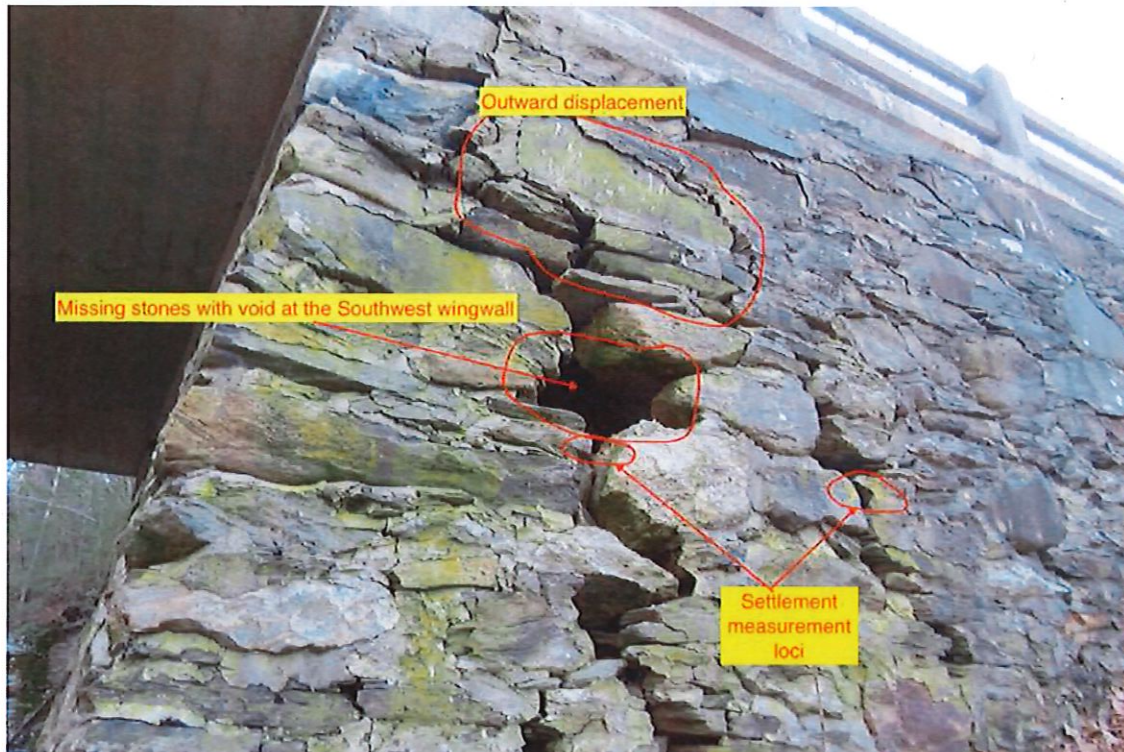
**Photo 7: Southwest wingwall deficiencies.**

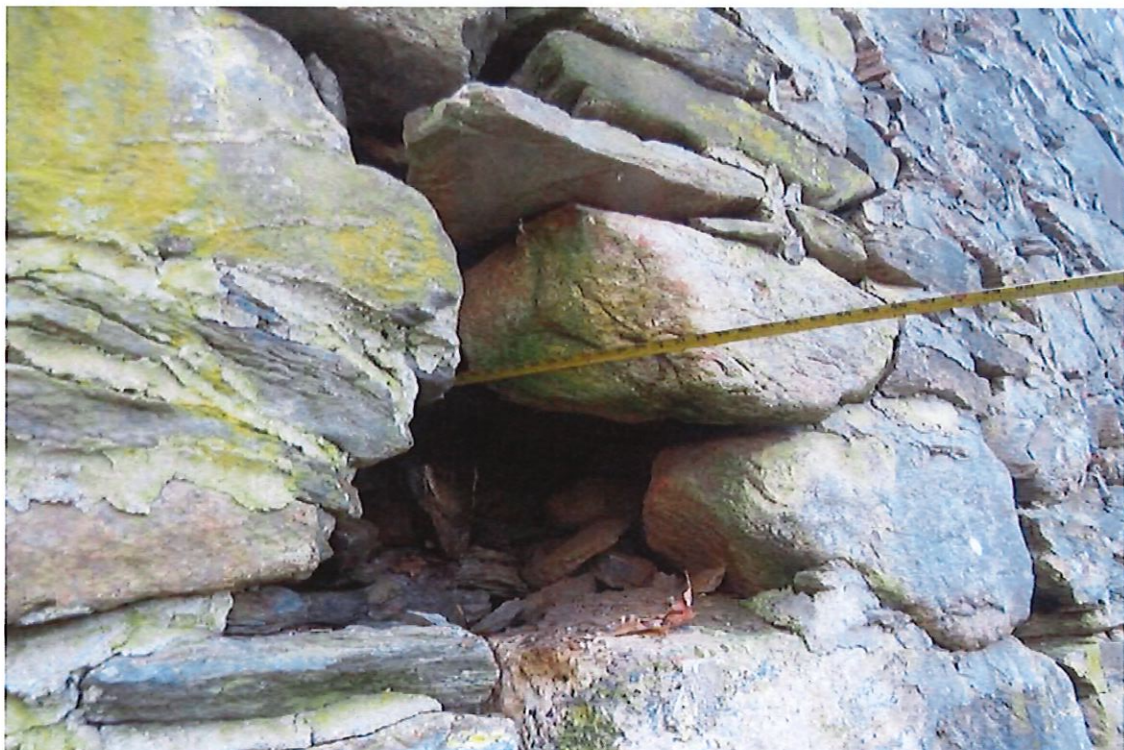
**Photo 8: Area of missing stones and void to the Southwest wingwall.**

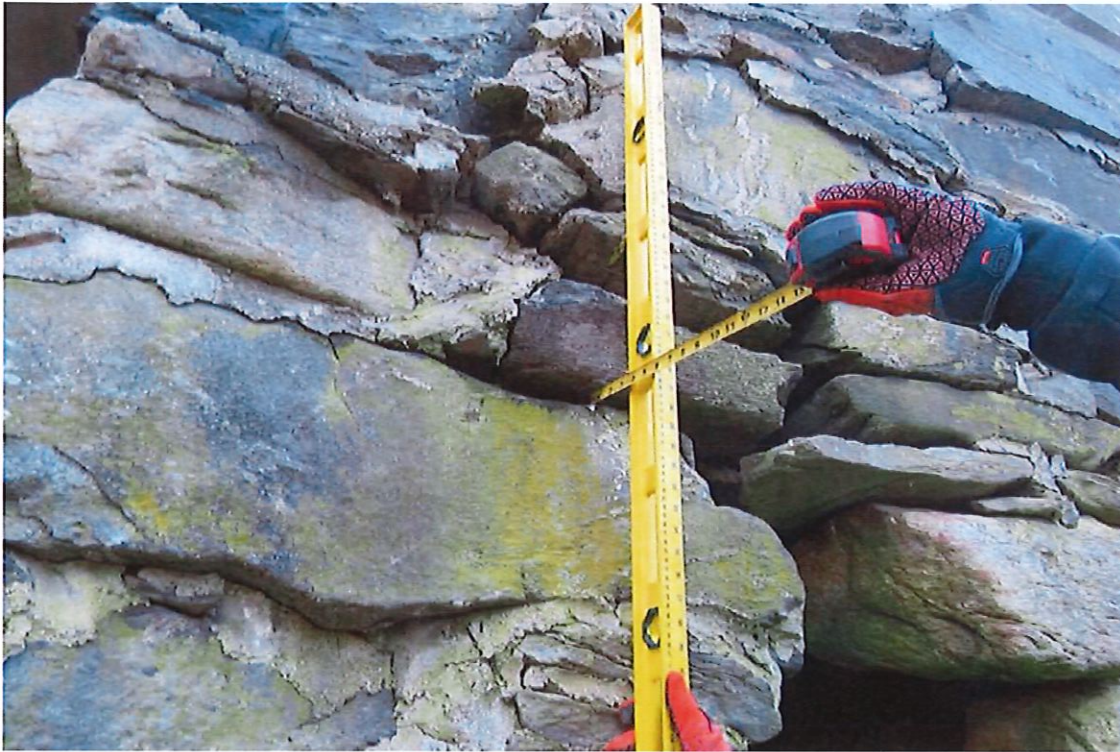
- Adjacent to breastwall; there is significant settlement, measured at two areas of full height separation between the stones, i.e. 3.5 inch wide at the North separation and 3 inch wide at the South separation, with up to 52 inches of penetration. Measurement loci have been marked with yellow keel. **See photos #7 and #8.**
- At mid-height; missing stones with a void up to 1.83 foot wide x 2 foot high x 3 foot deep.
- Overall outward displacement; 3 inches, taken using a 4 foot level on previous measurement locus. **See photo #9.**

**Photo 9: Outward displacement to the Southwest wingwall.**

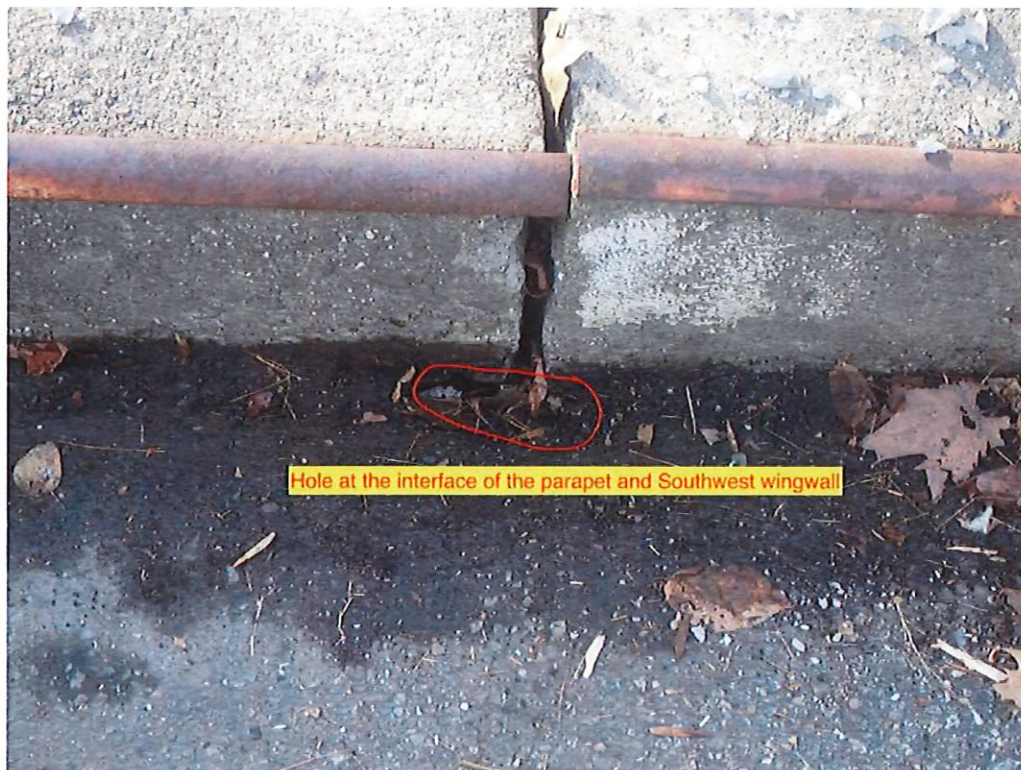
There is a hole at the interface of the wearing surface and the wingwall at the joint. **See photo #10.**

**Photo 10: Hole at the wearing surface and the Southwest wingwall.**

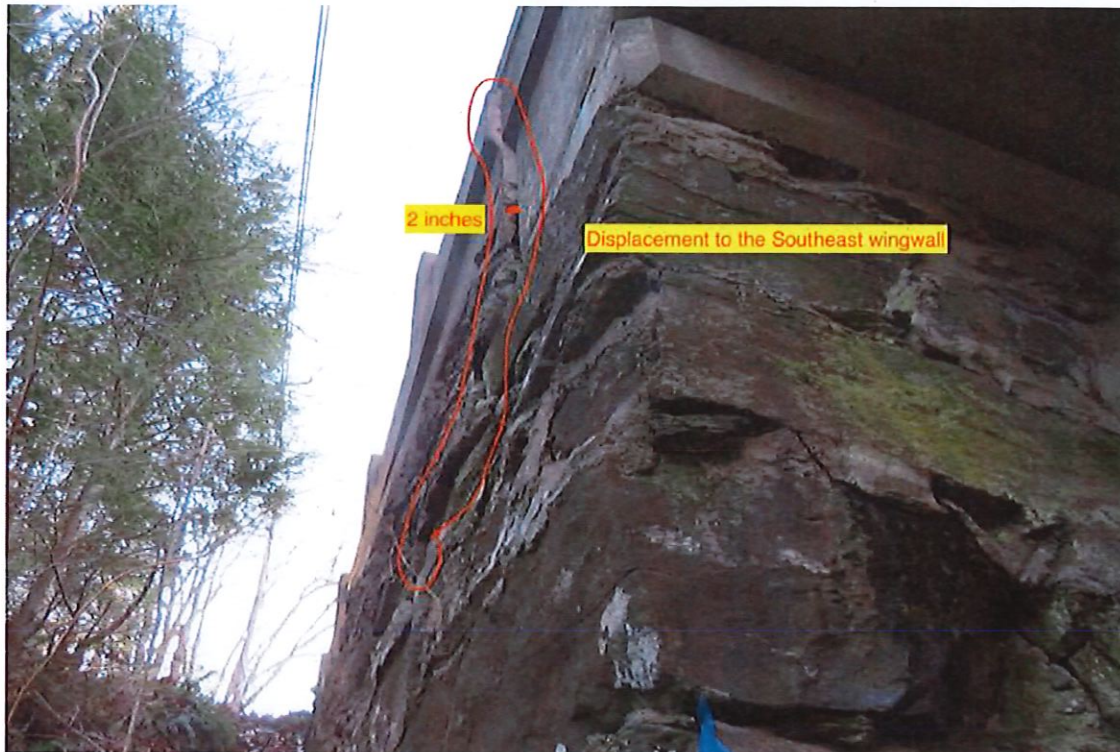
- Wingwall top has 2 inches of outward displacement (measured at the concrete rail base) and a full height crack along the pointing. **See photo #11.**

**Photo 11: Displacement to the Southeast wingwall.**

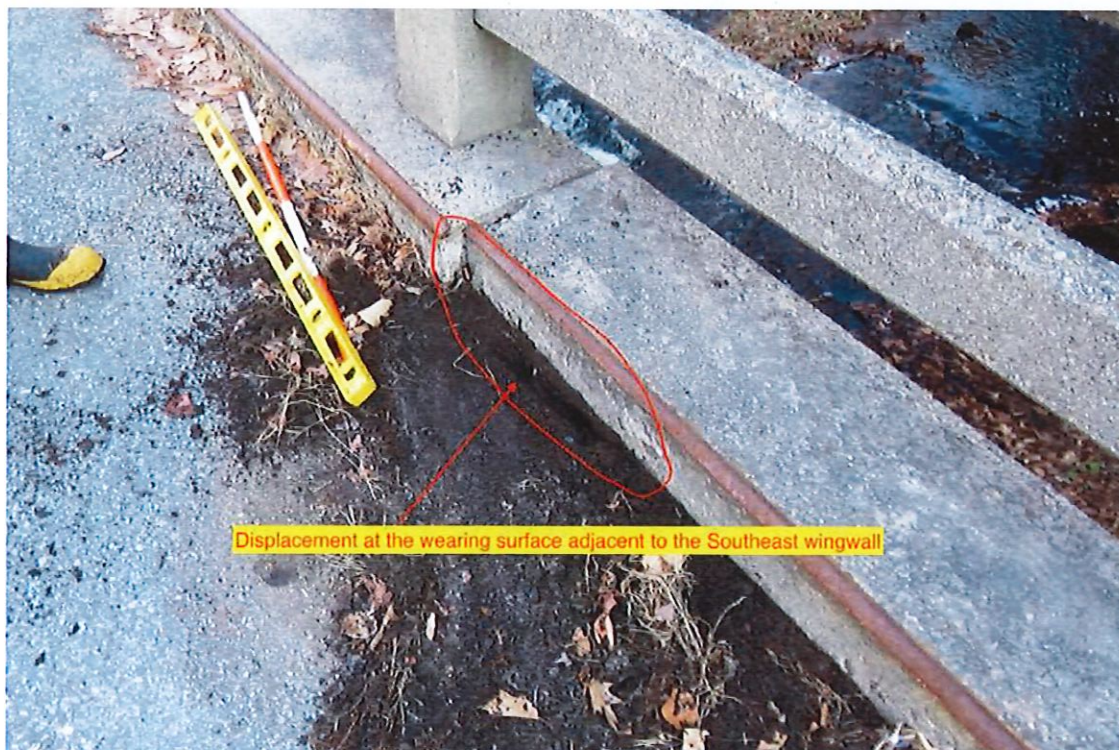
There is a 2 inch space at the top between the wearing surface and the wingwall. **See photo #12.**

**Photo 12: Displacement to the Southeast wingwall at the top.**

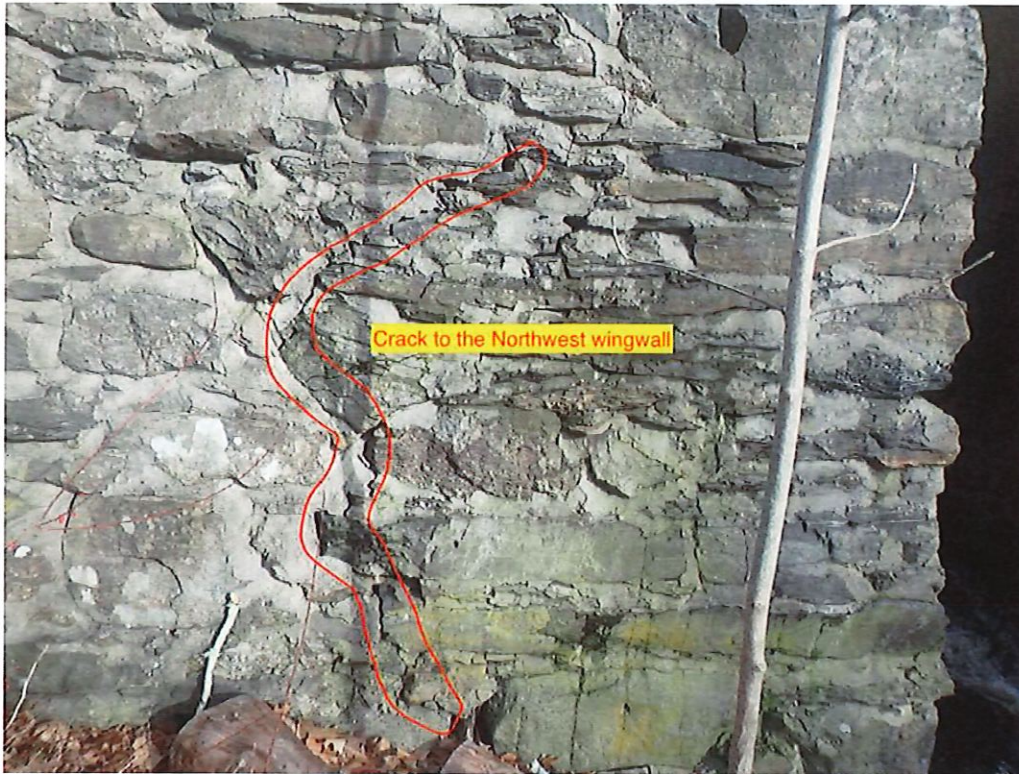
- Outward displacement; 1 inch with full height settlement crack (at pointing/stone interface). **See photo #13.**
- At wingwall/breastwall interface; cracked stone. **See photo #14.**

Photo 13: Northwest wingwall displacement and crack.

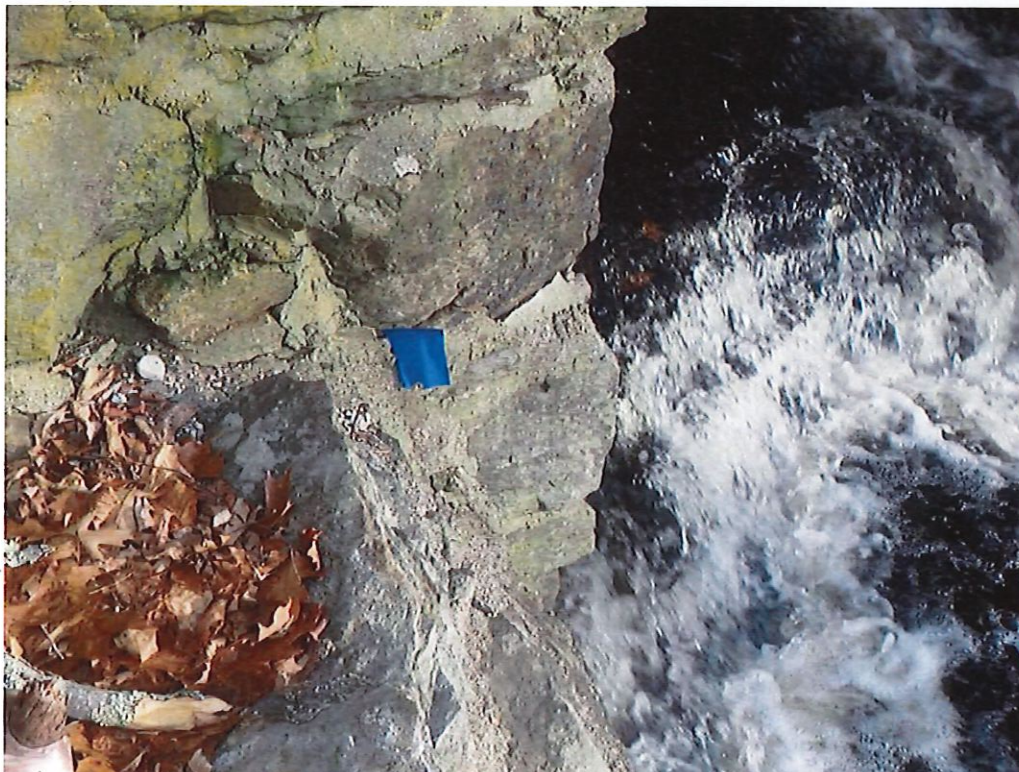
Photo 14: Cracked stone to the Northwest wingwall and breastwall interface.

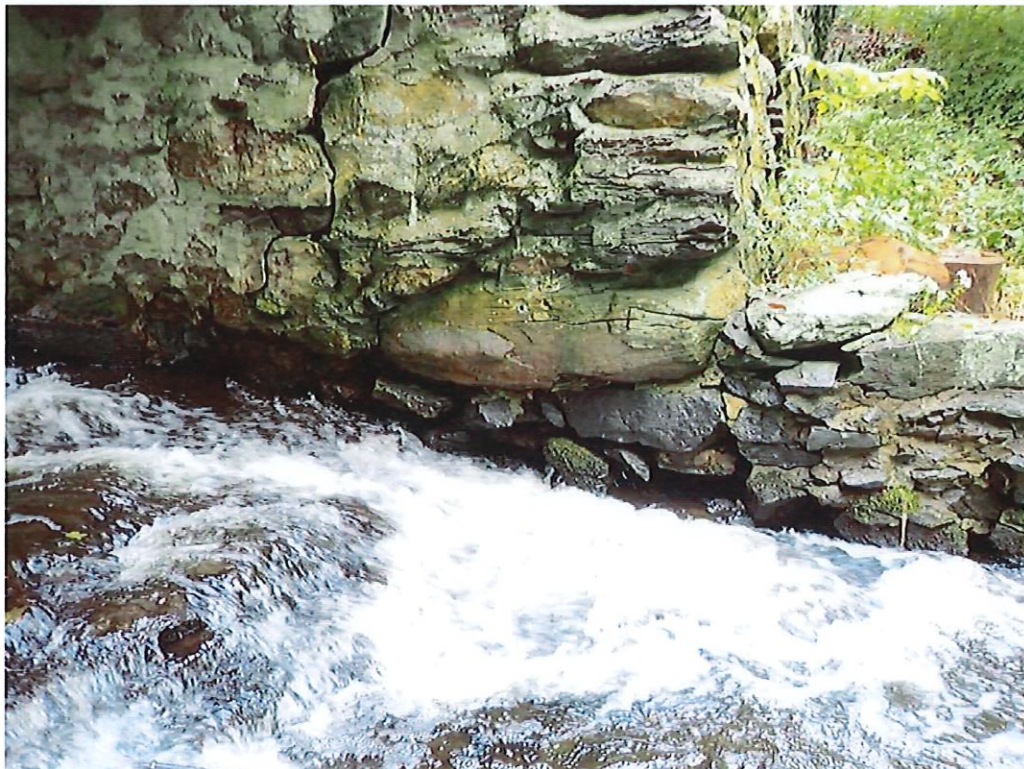
**Photo 2: South breastwall west end bottom voids, looking southeast.**

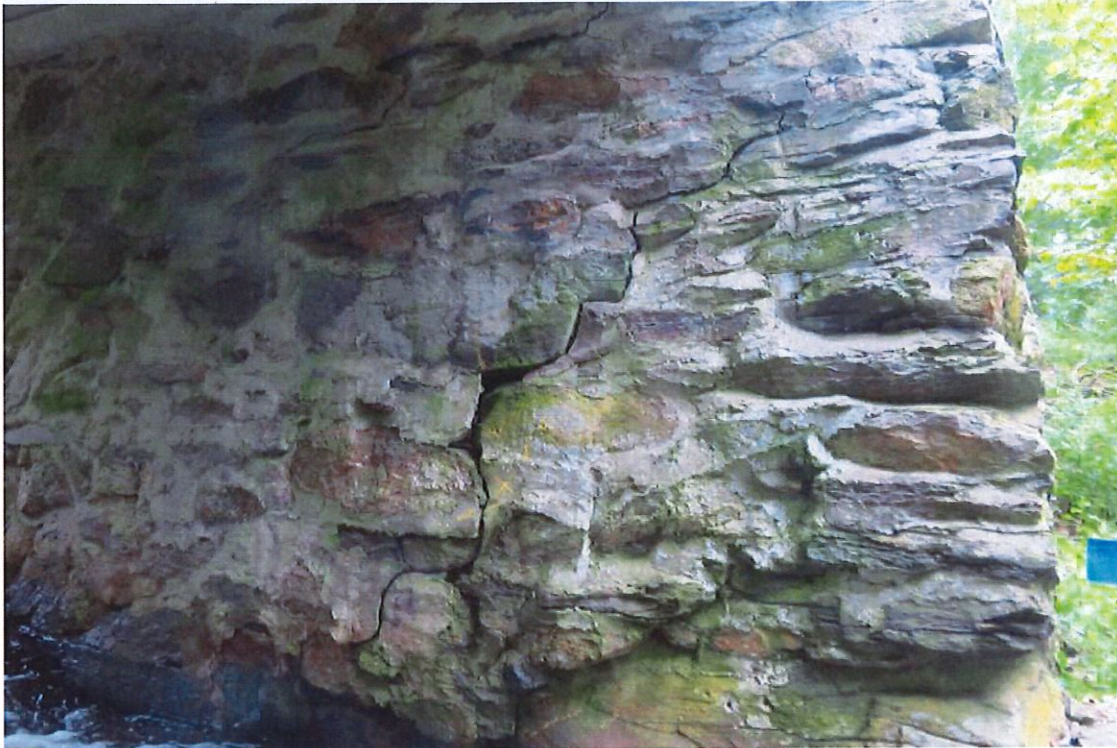
Photo 1: South breastwall, west end crack.

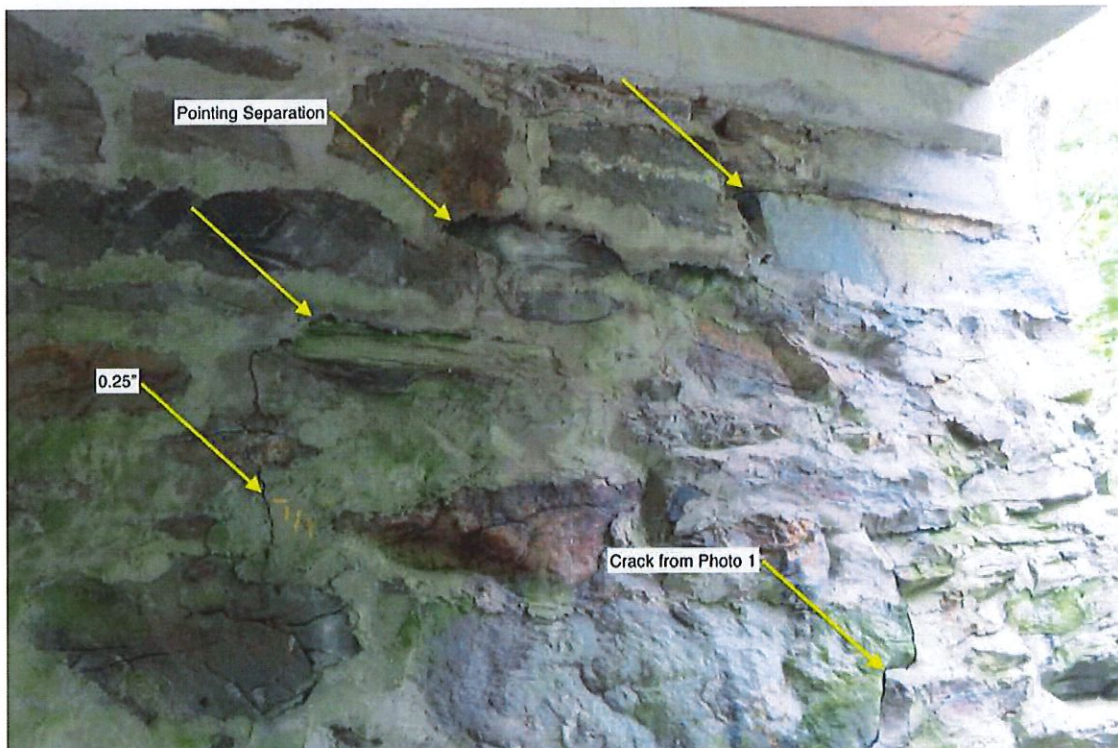
Photo 2: South breastwall, new settlement crack.

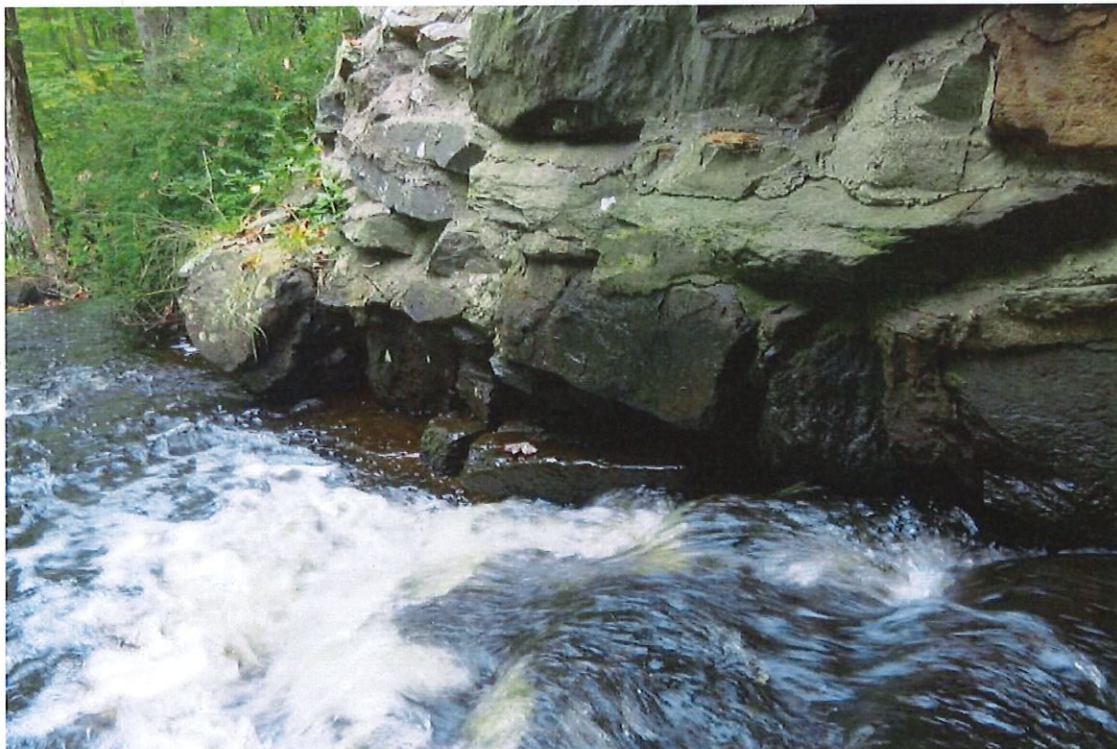
Photo 4: North breastwall, west end bottom gap in masonry.

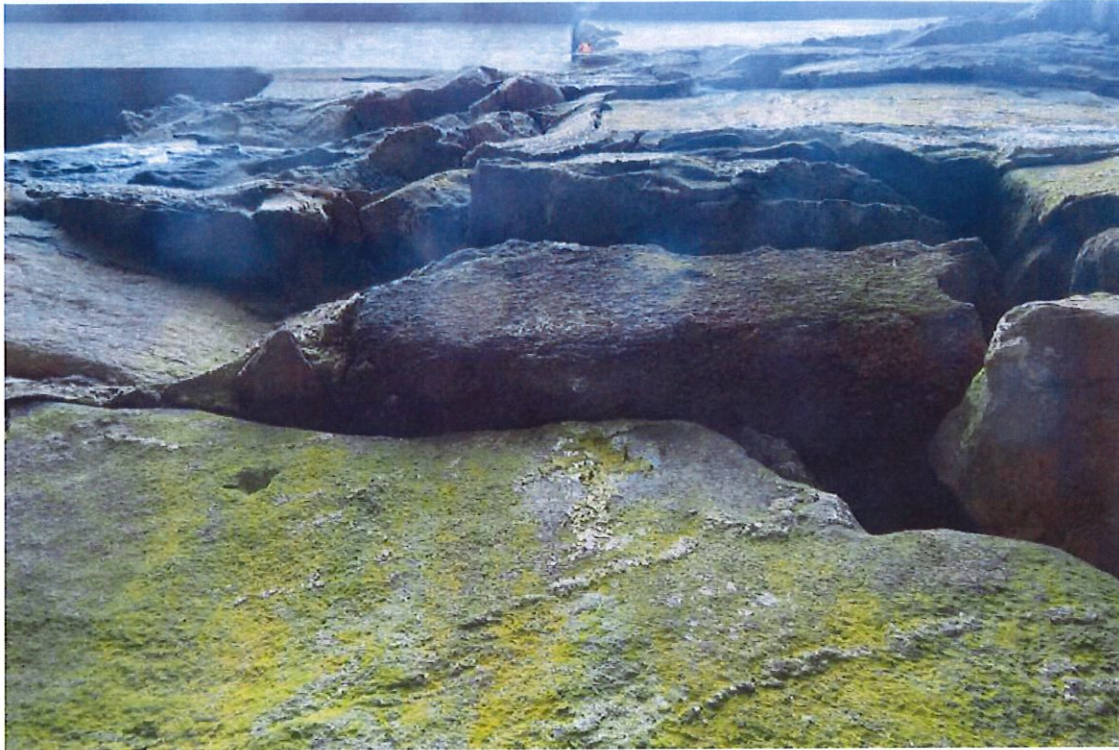
**Photo 6:** Southwest wingwall, outward displacement locus closeup.
