## STRUCTURES INSPECTION FIELD REPORT

BR. DEPT. NO.  
**P-02-003**

## SPECIAL MEMBER INSPECTION

CITY/TOWN <b>PAXTON</b>	8-STRUCTURE NO. <b>P02003-6UX-MUN-BRI</b>	11-Kilo. POINT <b>000.306</b>	90-ROUTINE INSP. DATE <b>Dec 3, 2021</b>	93*-SPEC. MEMB. INSP. DATE <b>Jun 21, 2023</b>
07-FACILITY CARRIED <b>HWY BLACK HILL R</b>	MEMORIAL NAME/LOCAL NAME	27-YR BUILT <b>1850</b>	106-YR REBUILT <b>1929</b>	*YR REHAB'D (NON 106) <b>0000</b>
06-FEATURES INTERSECTED <b>WATER TURKEY HILL BROOK</b>	26-FUNCTIONAL CLASS <b>Rural Local</b>	DIST. BRIDGE INSPECTION ENGINEER <b>M. Azizi</b>		
43-STRUCTURE TYPE <b>101 : Concrete Slab</b>	22-OWNER <b>Town Agency</b>	21-MAINTAINER <b>Town Agency</b>	TEAM LEADER <b>R. Rogers</b>	
107-DECK TYPE <b>1 : Concrete Cast-in-Place</b>	WEATHER <b>sunny</b>	TEMP. (air) <b>17°C</b>	TEAM MEMBERS <b>B. SANTEUFEMIO</b>

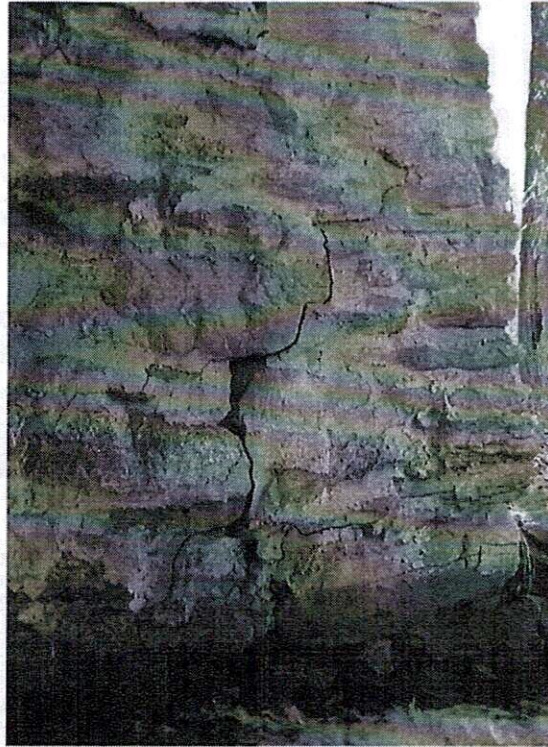
Photo 1: South breastwall, west end crack.

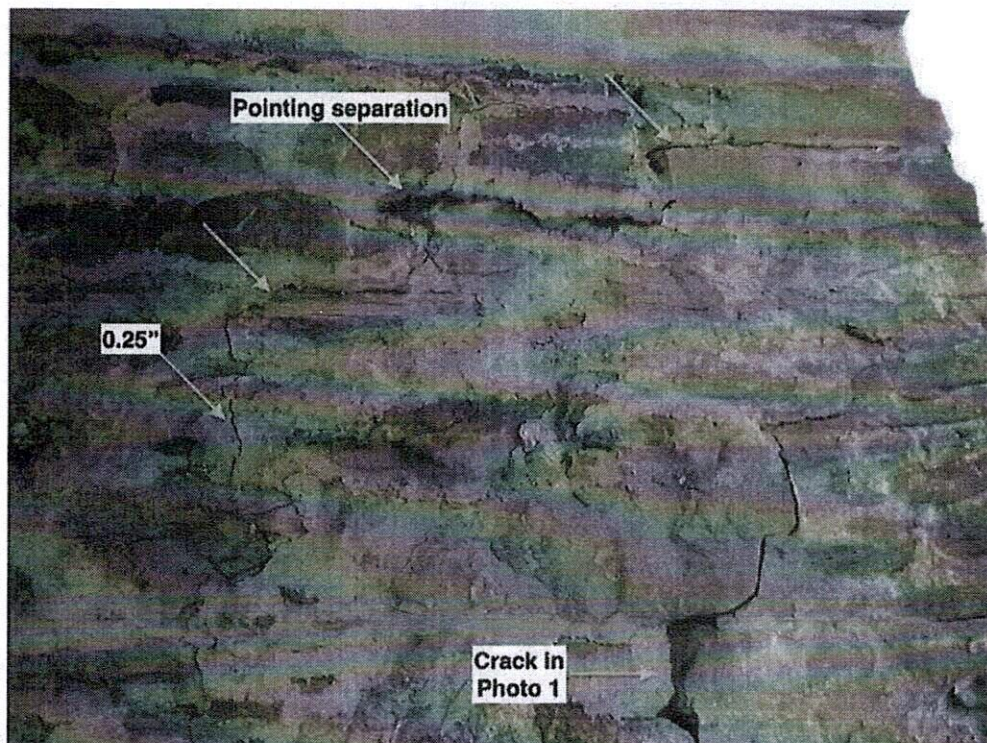
Photo 2: South breastwall, new settlement crack.

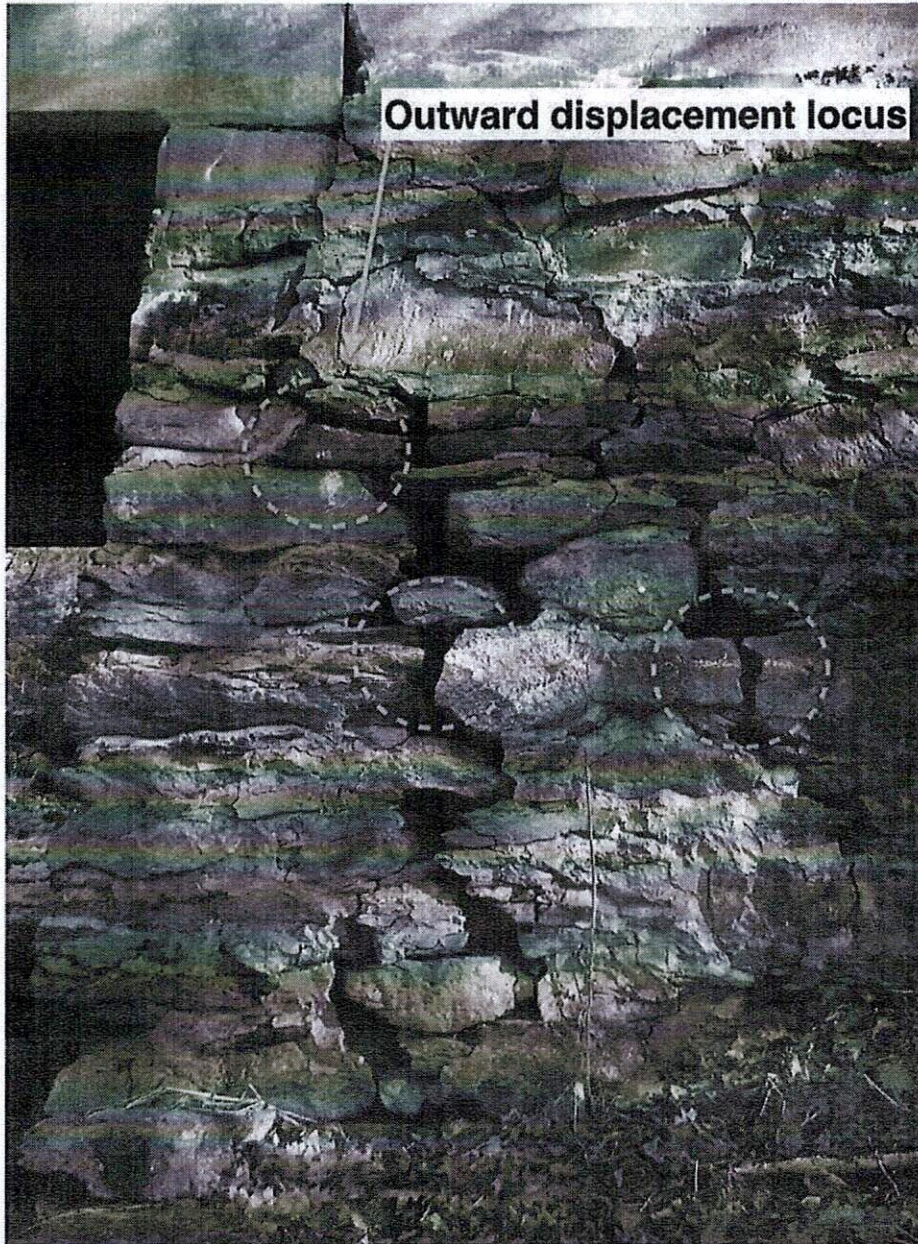
**Photo 5:** Southwest wingwall, settlement and measurement loci.

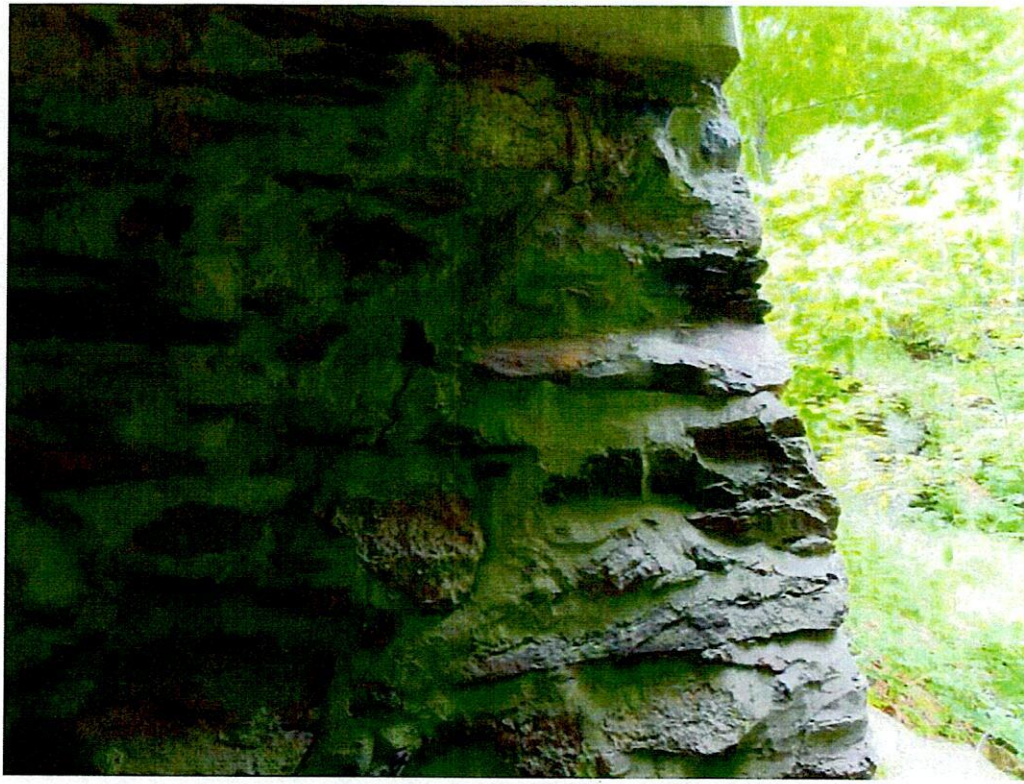
Photo 1: Cracking to the pointing at the Northeast corner.

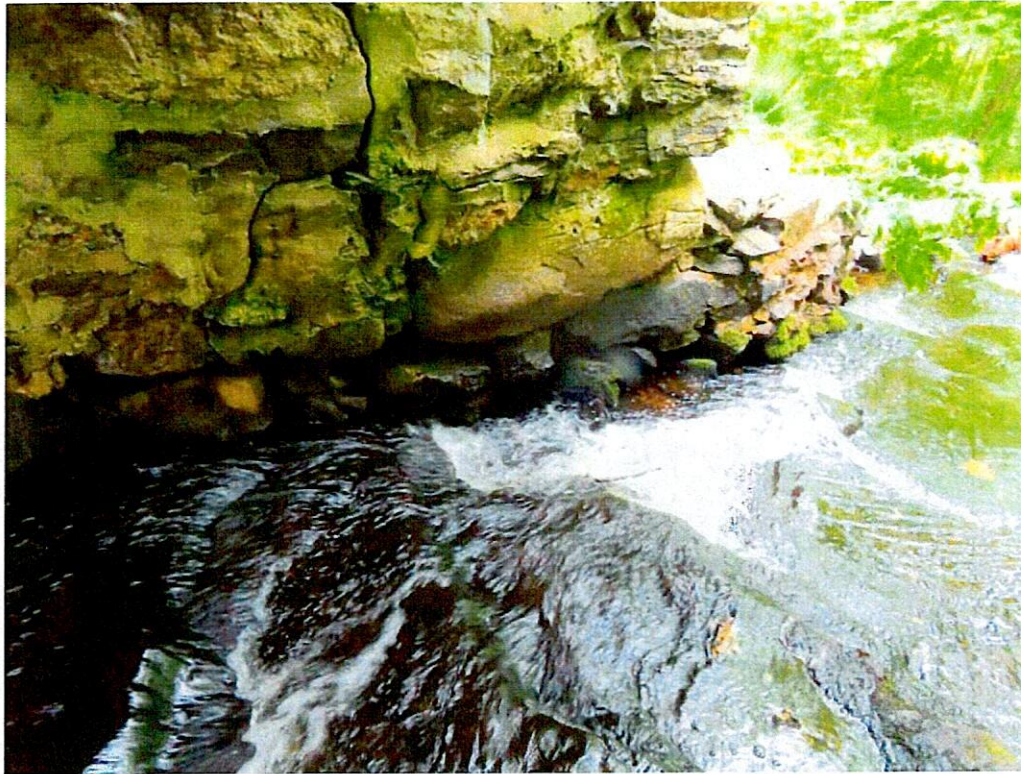
Photo 3: Void due to missing/dislodged stones. Note the settlement of the corner above the void.

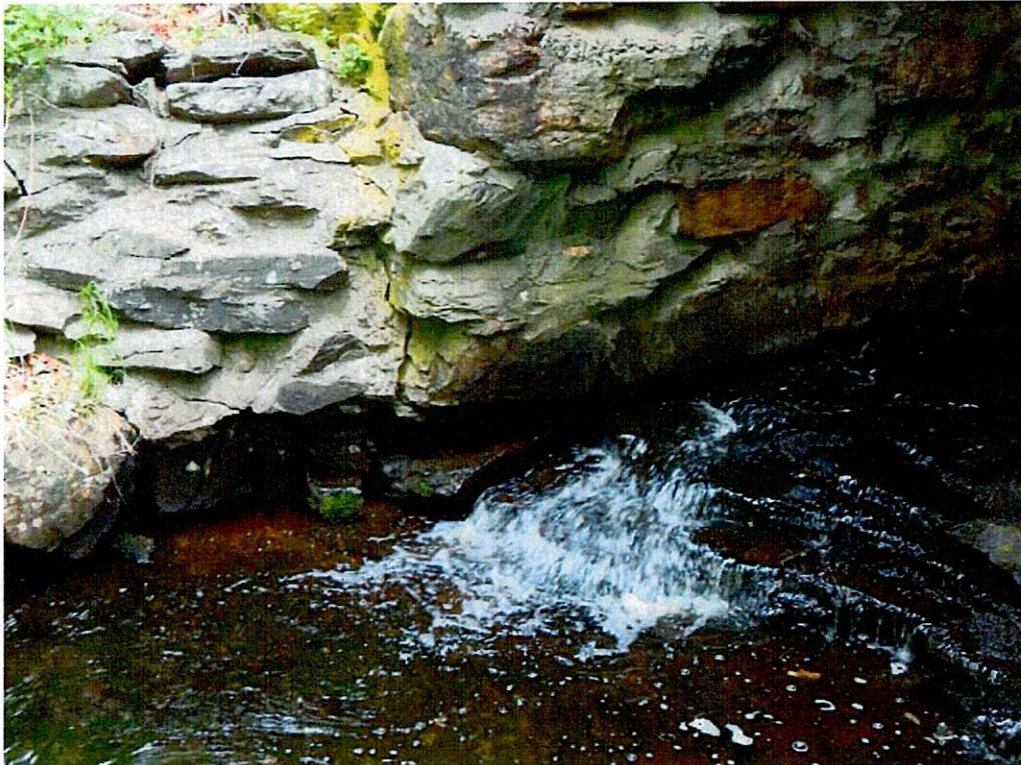
Photo 4: Dislodged stone at the Northwest corner.

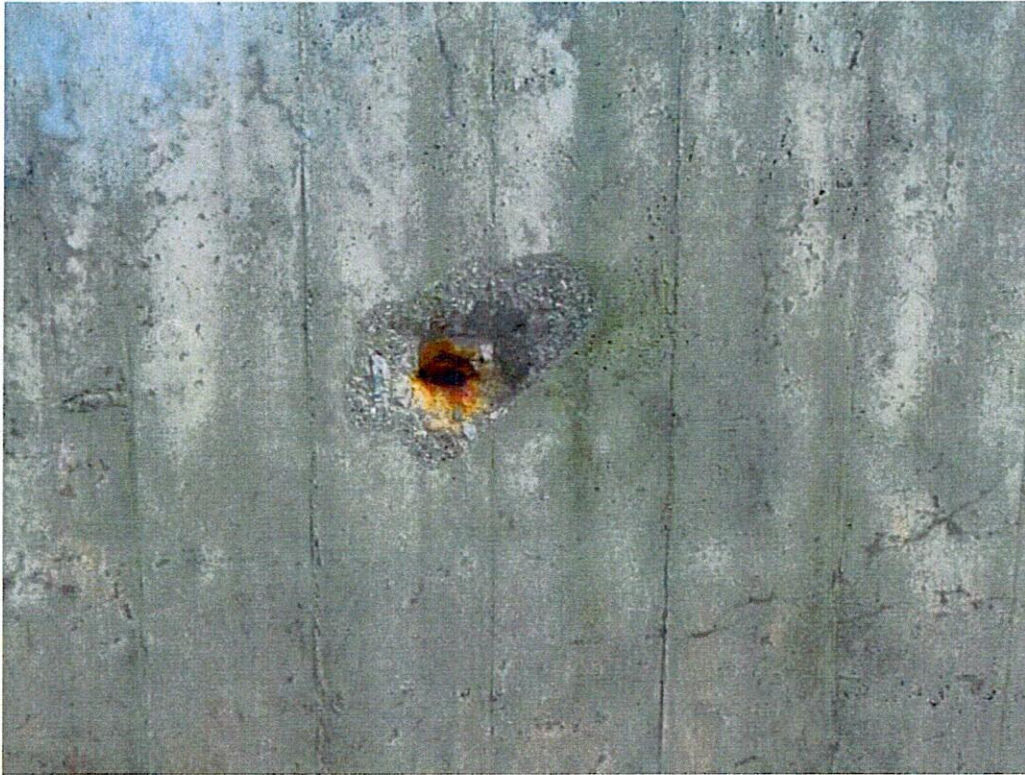
Photo 1: Spall to the North end of the deck slab.

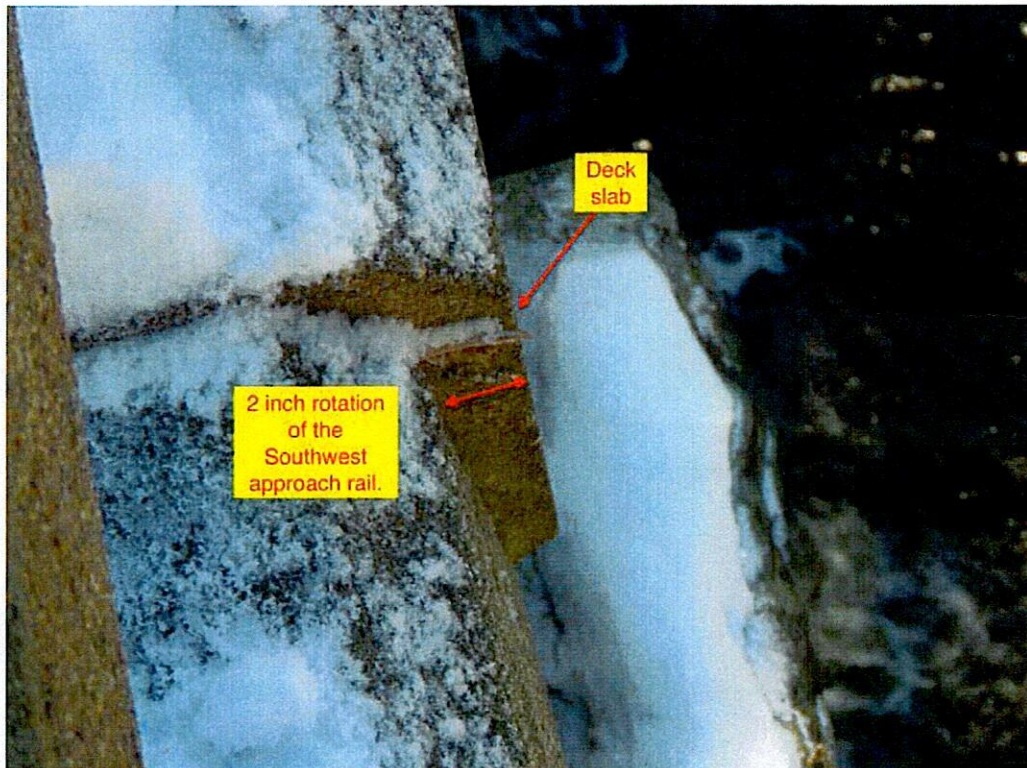
Photo 2: Rotation of the Southwest approach rail at the deck slab.

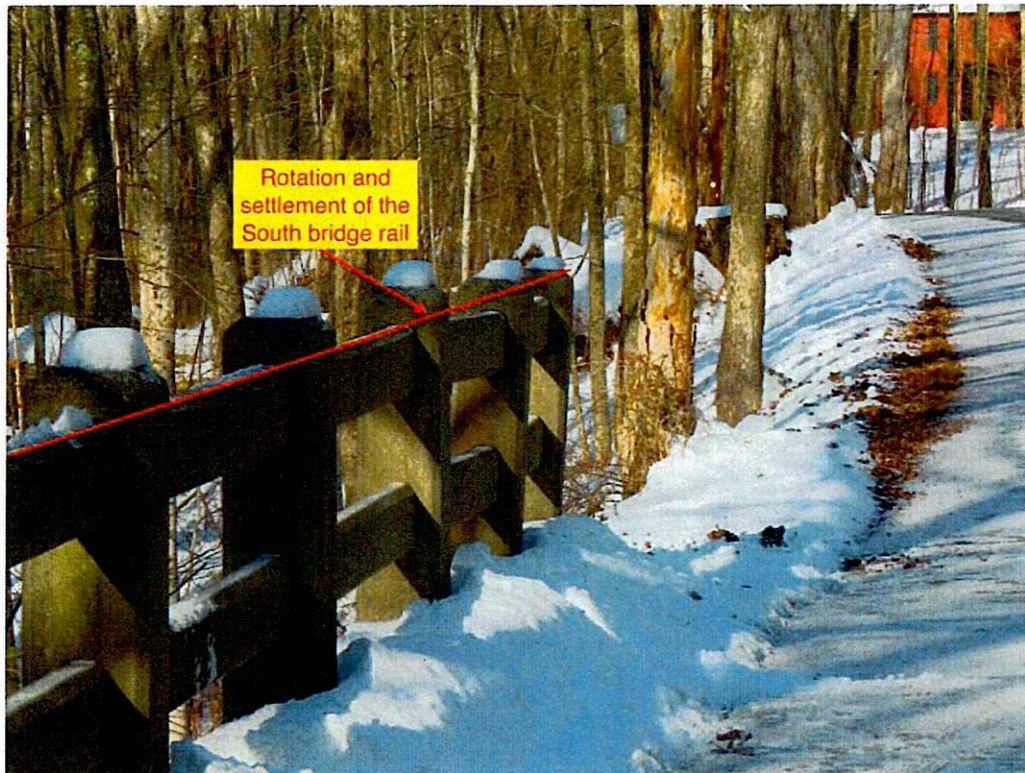
Photo 3: Rotation and settlement of the Southwest approach rail.

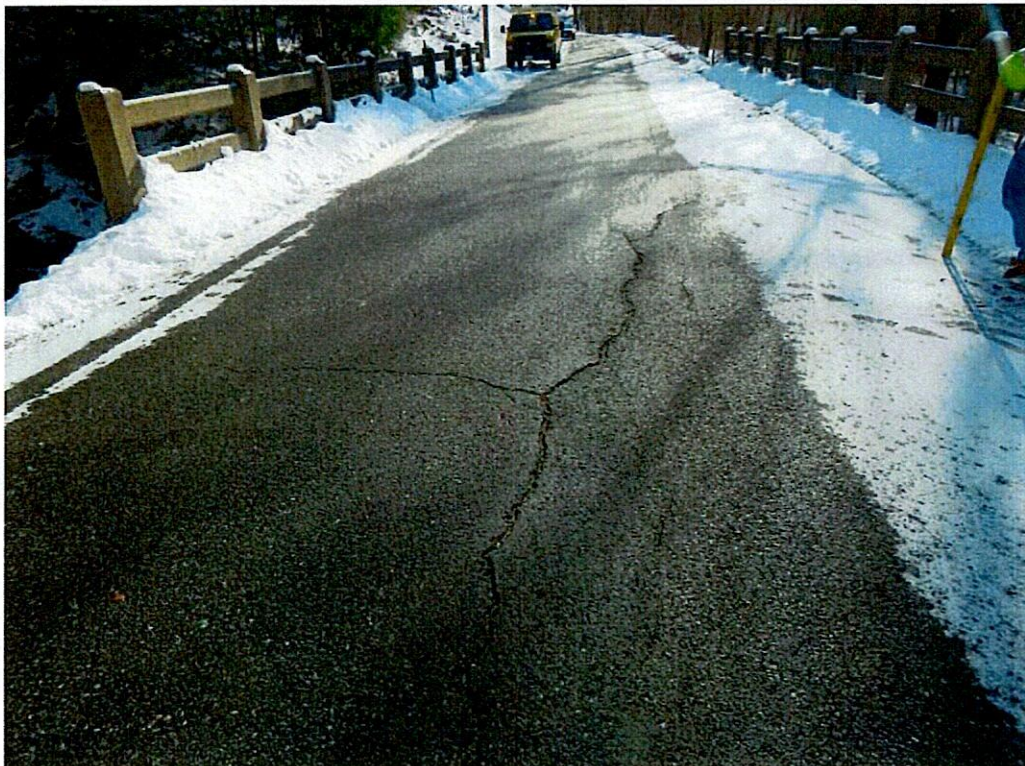
Photo 4: Cracks to the West approach pavement.

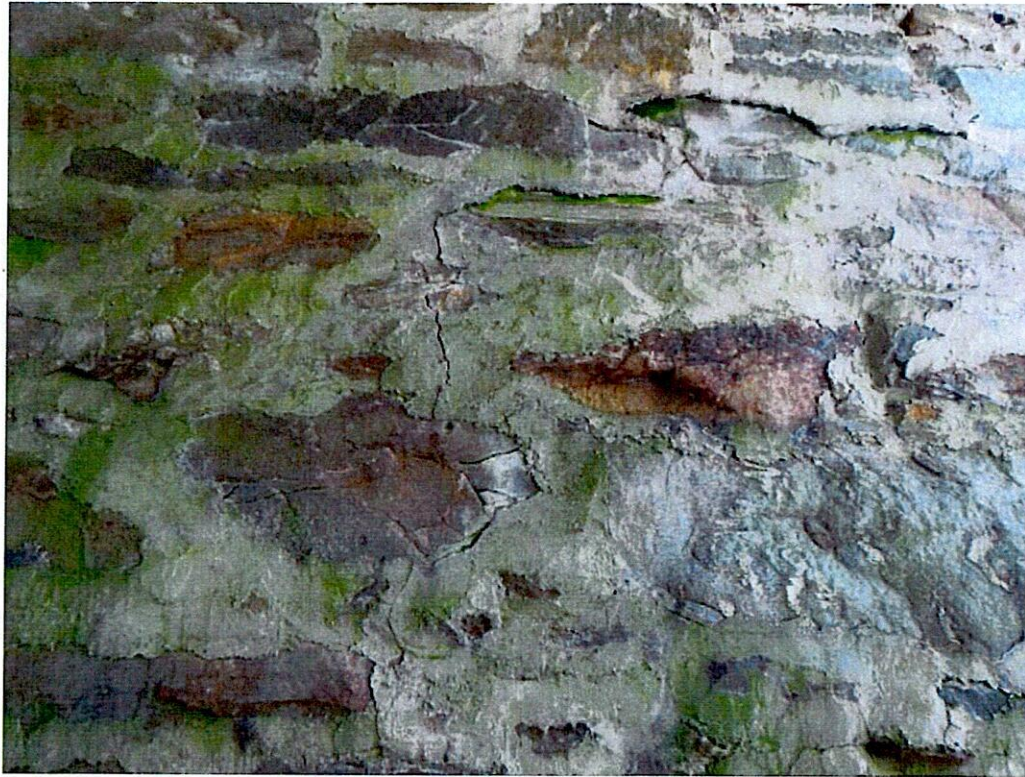
Photo 5: Cracked stone and pointing at the East breastwall near South end.

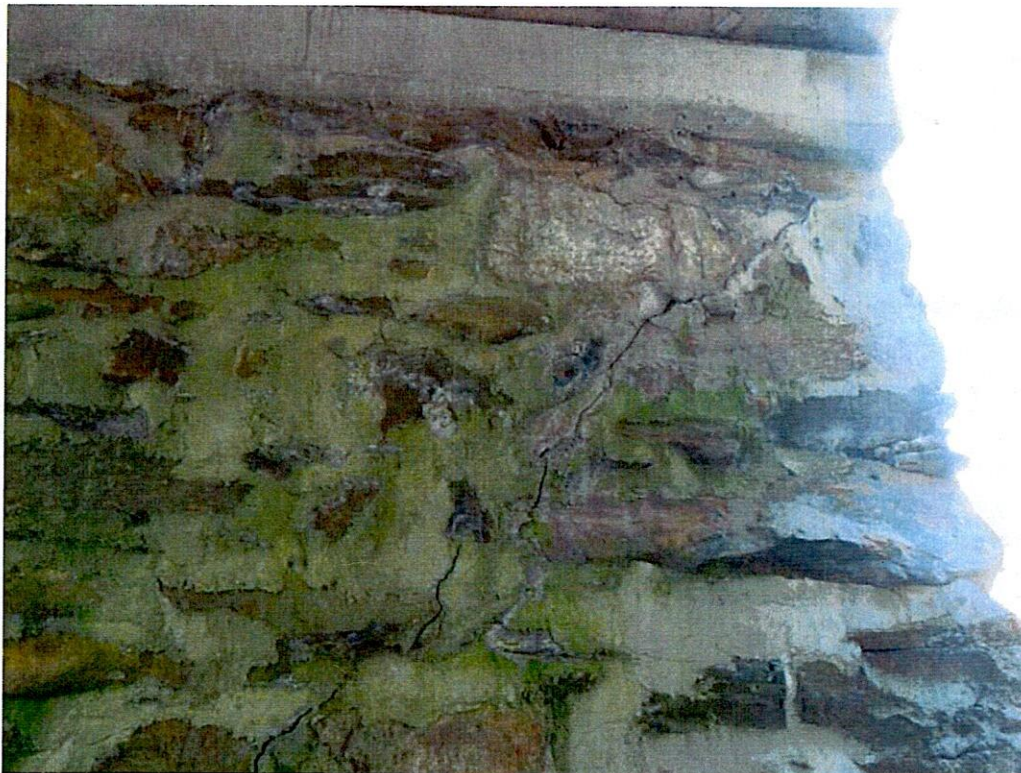
Photo 6: Diagonal crack to the West breastwall at the North end.

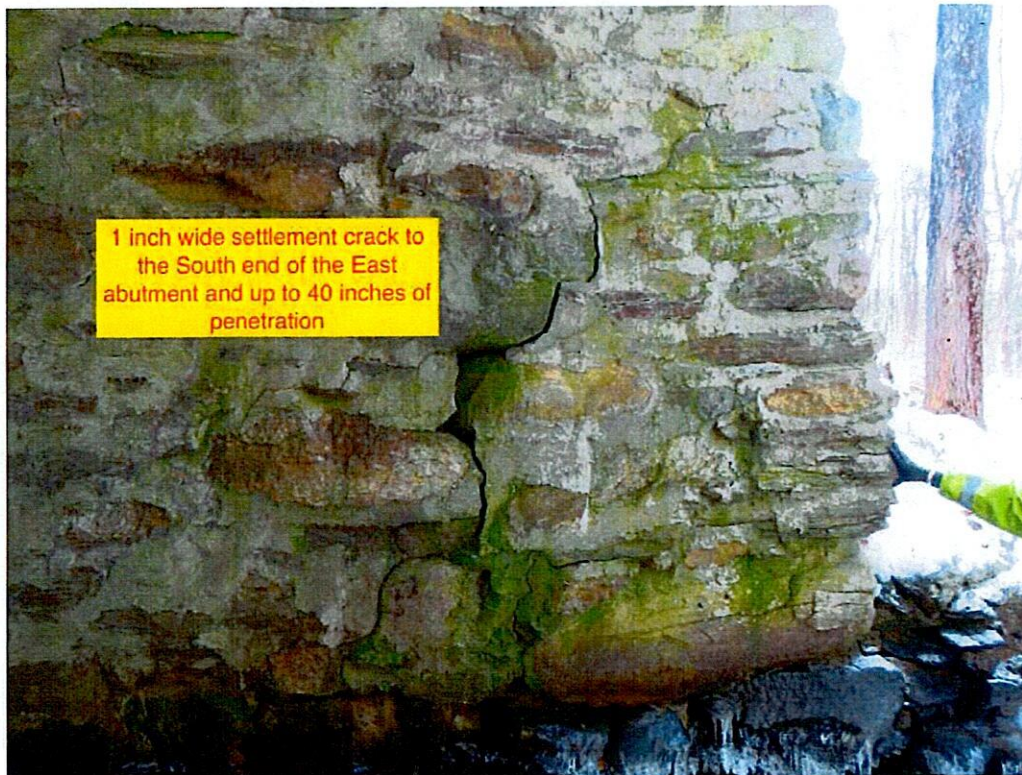
Photo 7: Settlement crack to the East breastwall at the South end.

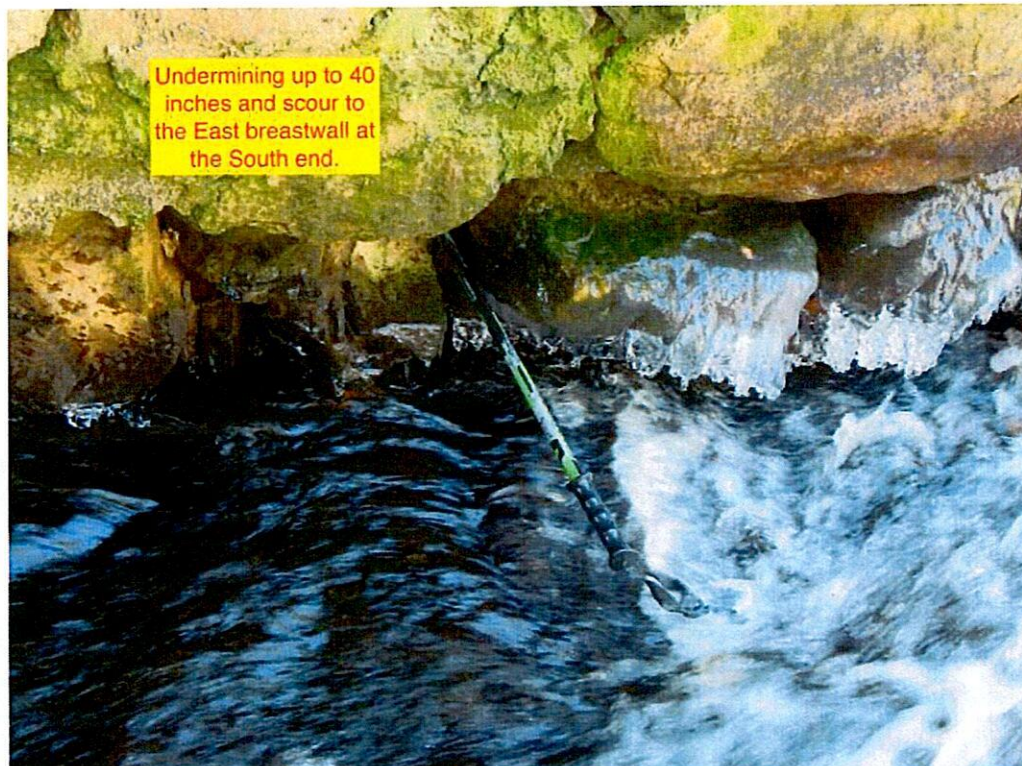
Photo 8: Undermining and scour to the South end of the East breastwall.

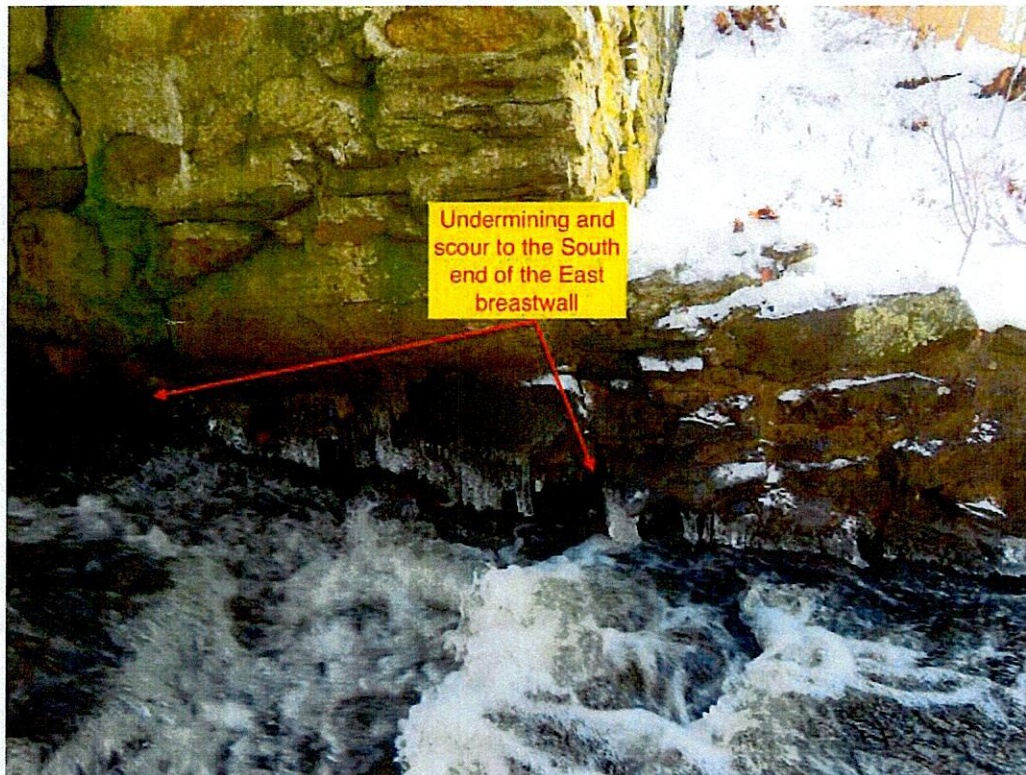
Photo 9: Undermining and scour to the South end of the East breastwall.

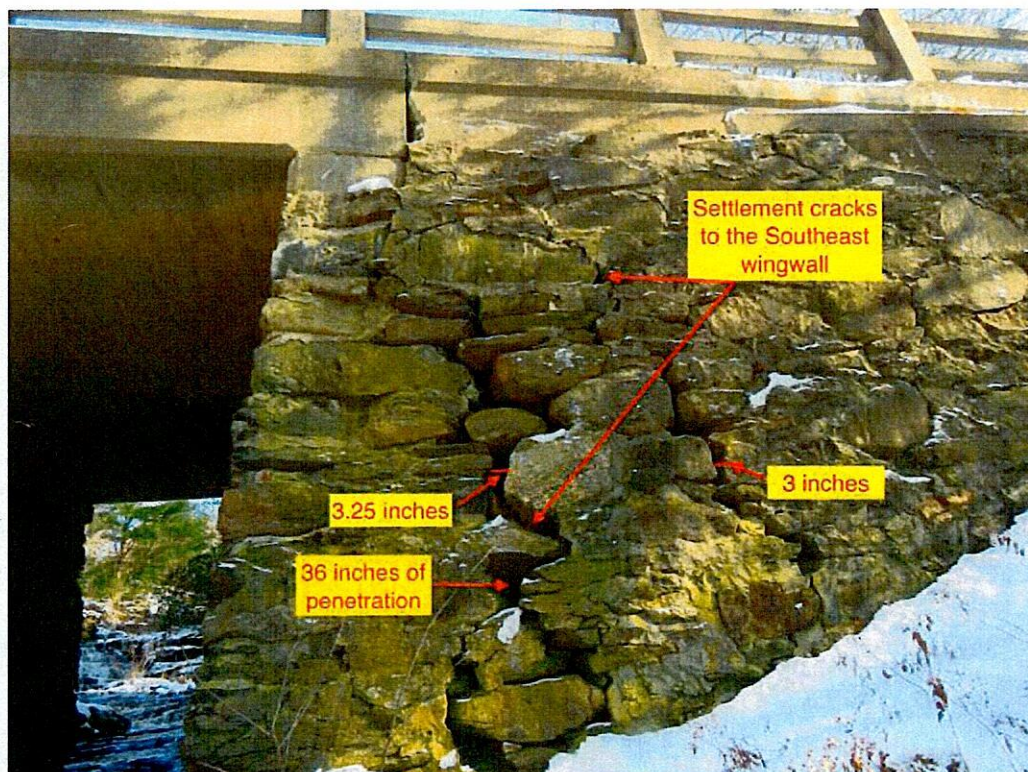
Photo 10: Large settlement cracks to the Southeast wingwall.

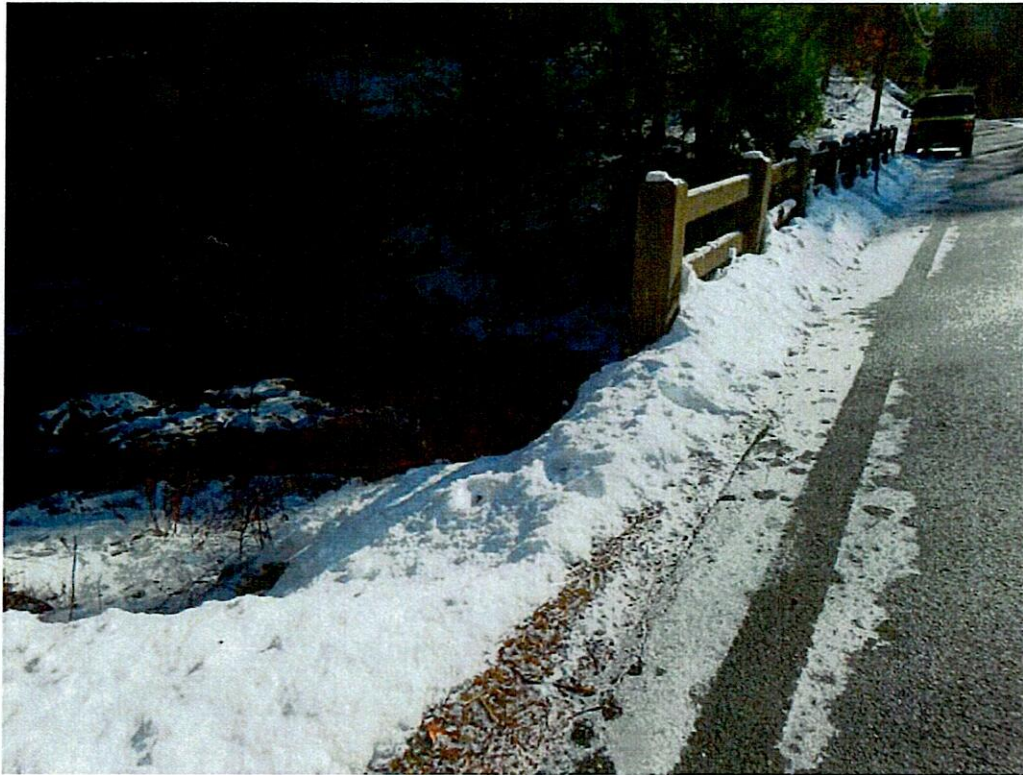
Photo 11: Area of erosion to the Northwest embankment.
