Paxton

Schematic Design Report

New Public Works Facility

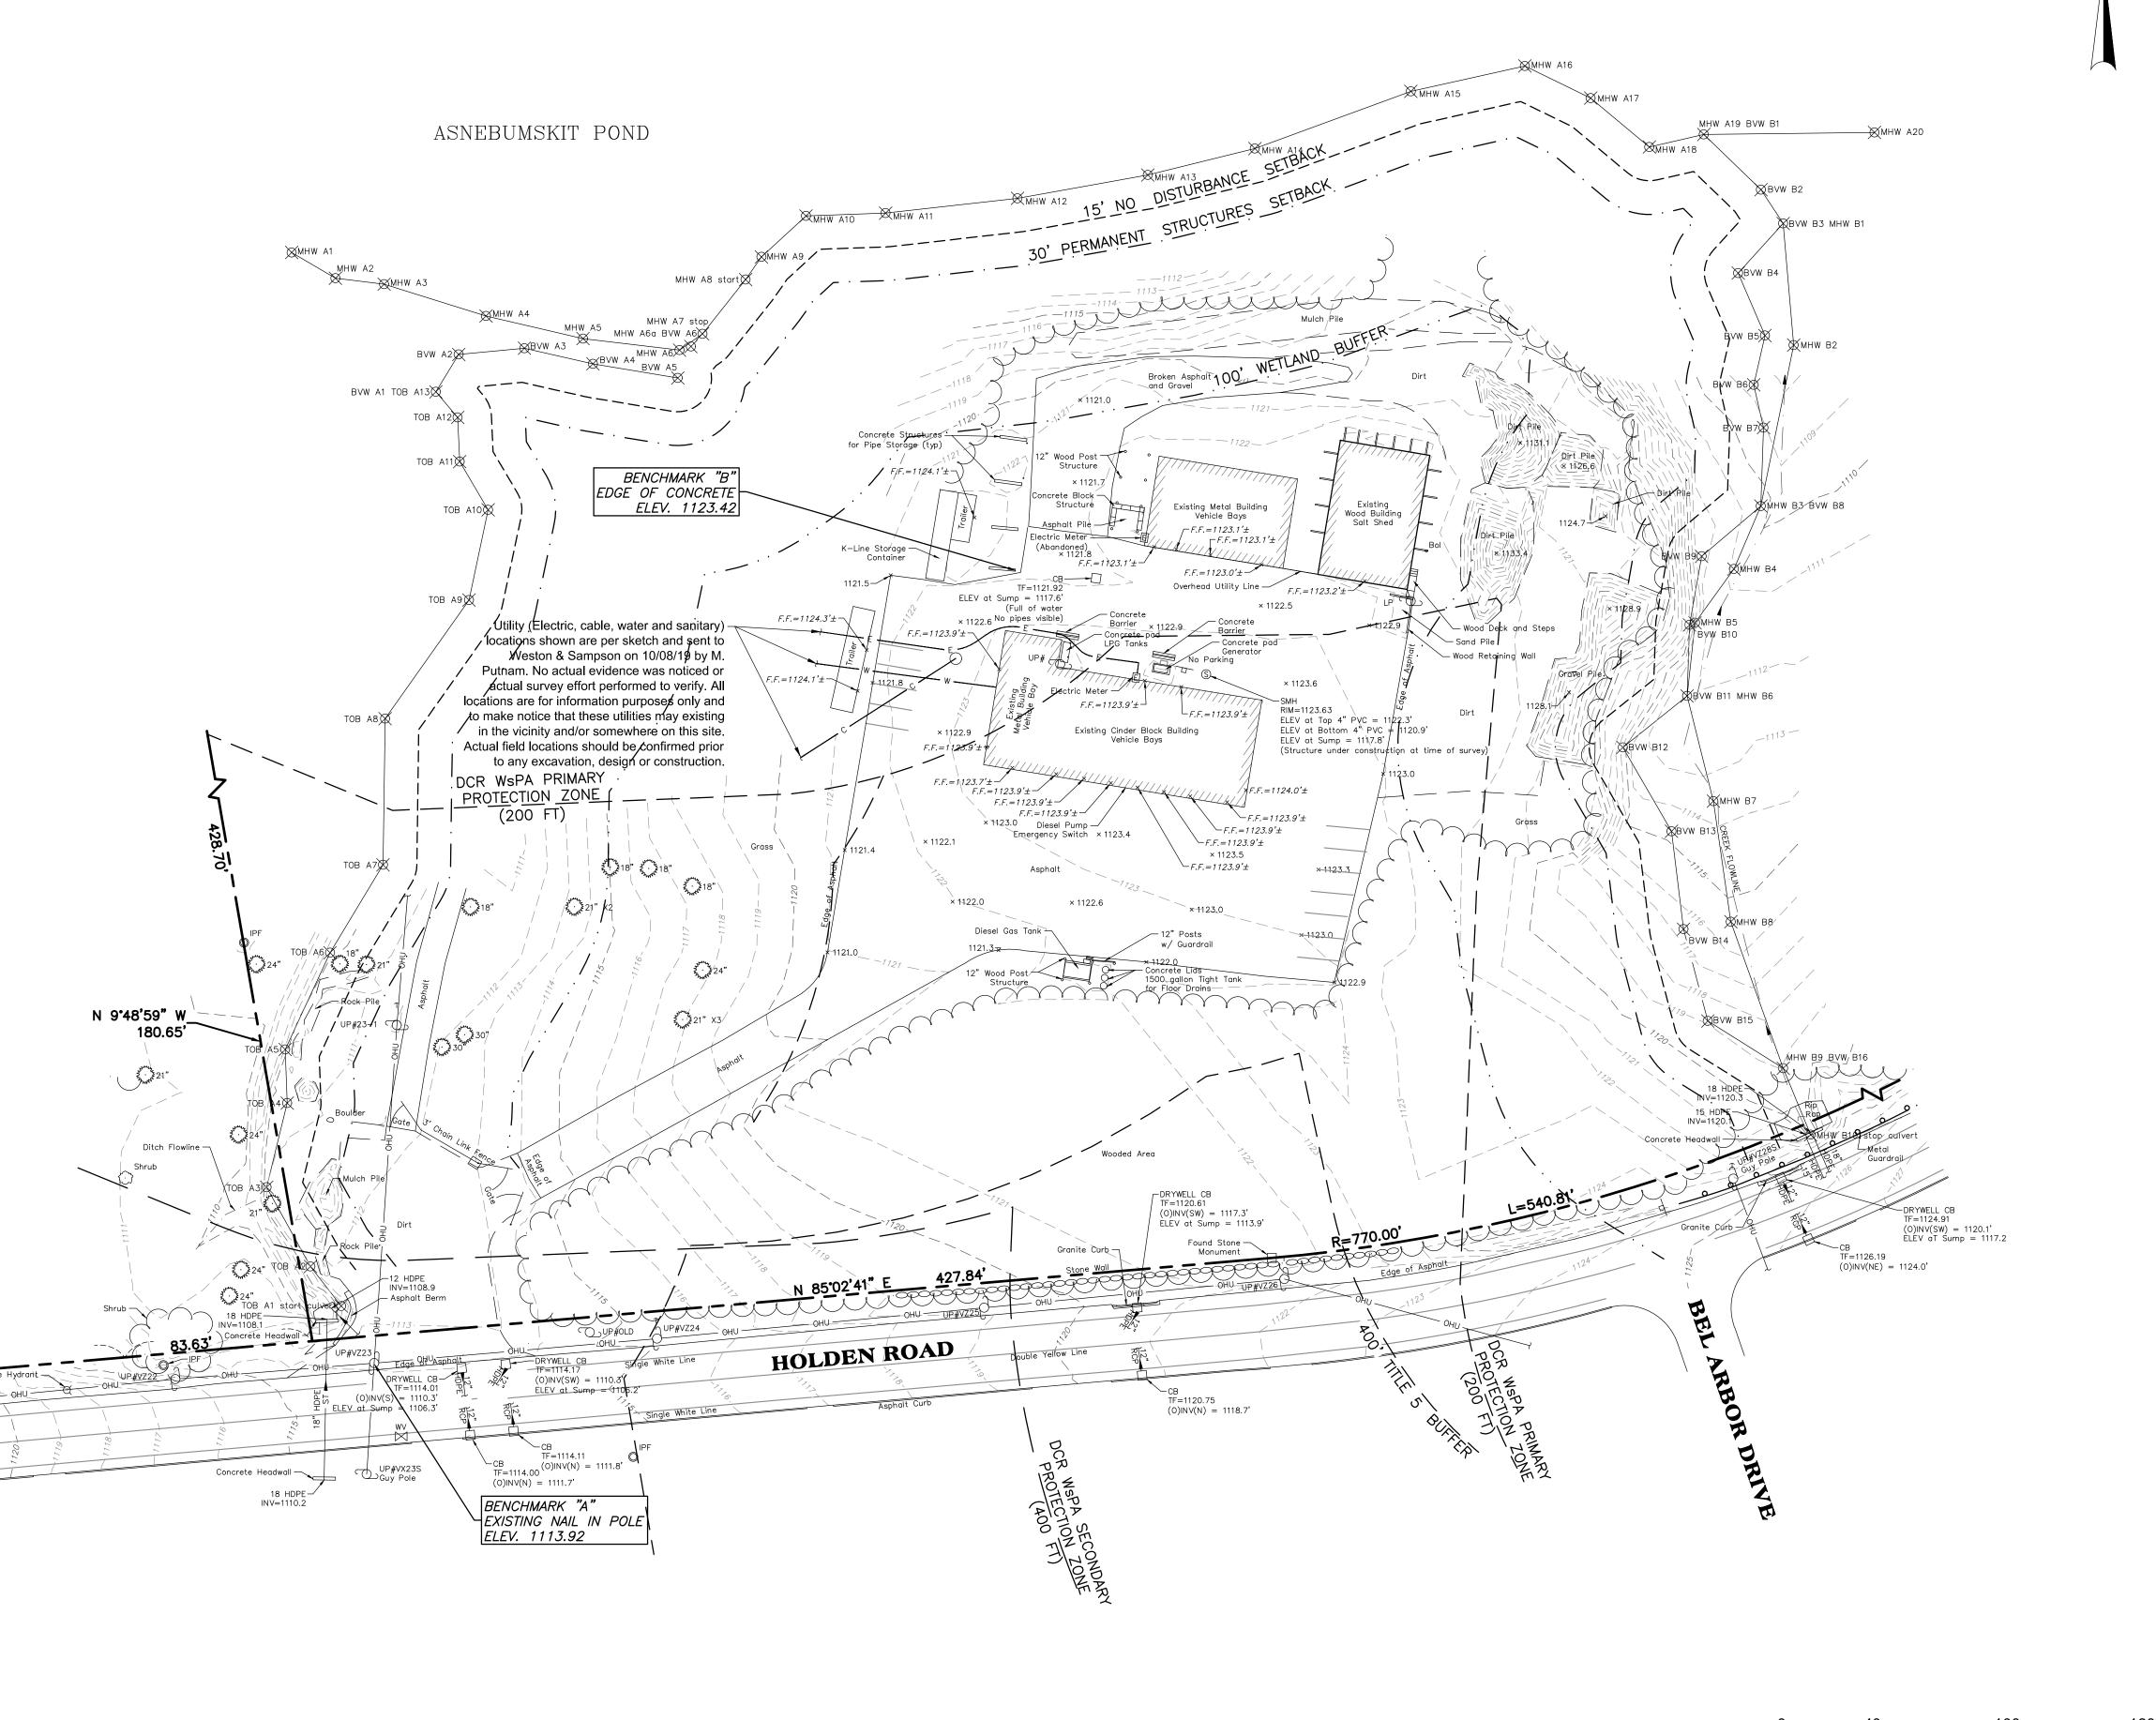
W&S File No:
Drawing Title:
EXISTING CONDITIONS PLAN
Sheet Number:

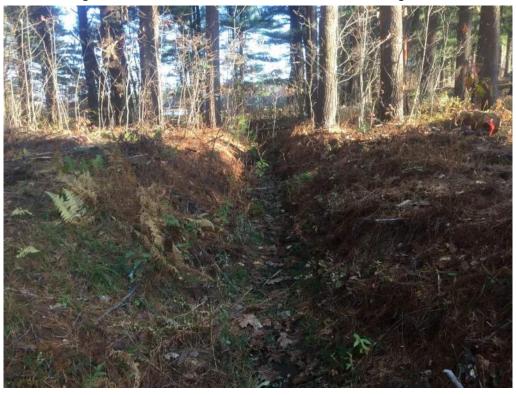
Figure 1: Intermittent Stream Identified with TOB A Flag Series

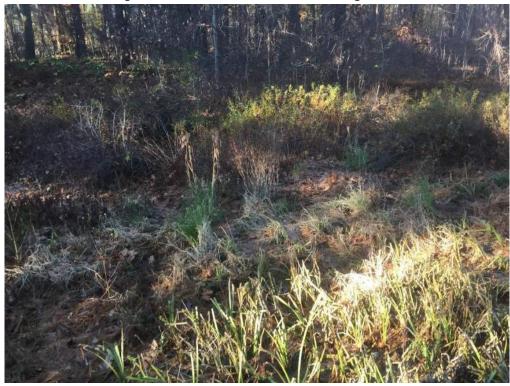
Figure 2: BVW Identified with BVW A Flag Series

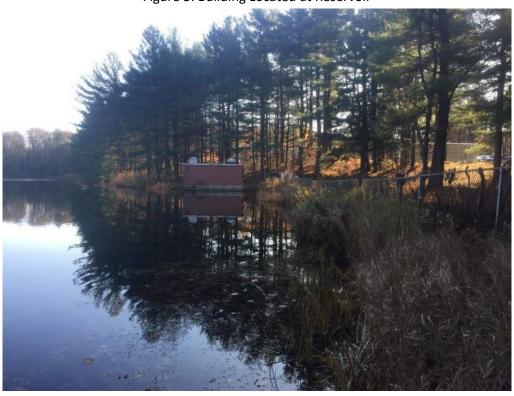
Figure 3: Building Located at Reservoir

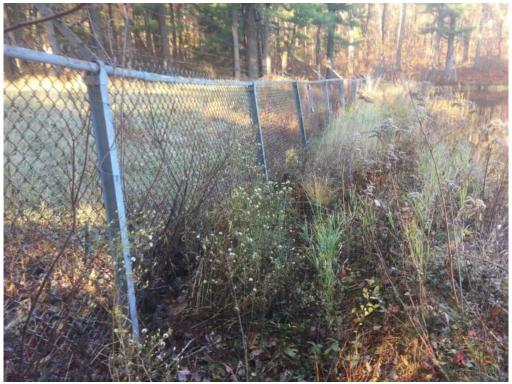
Figure 4: Reservoir Berm and Fence

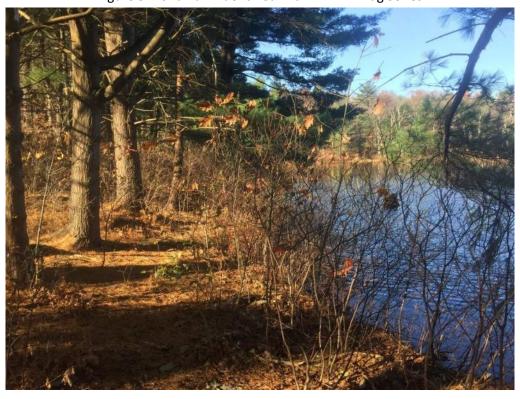
Figure 5: Pond Bank Identified with MHW A Flag Series

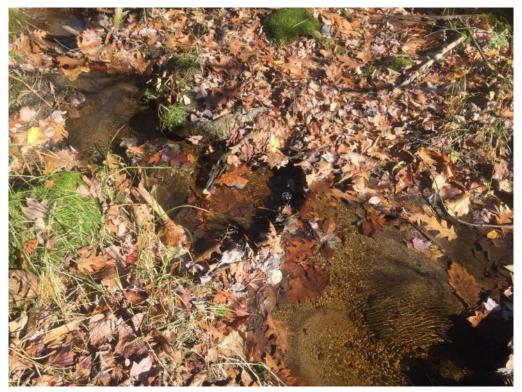
Figure 6: Intermittent Stream Identified with MHW B Flag Series

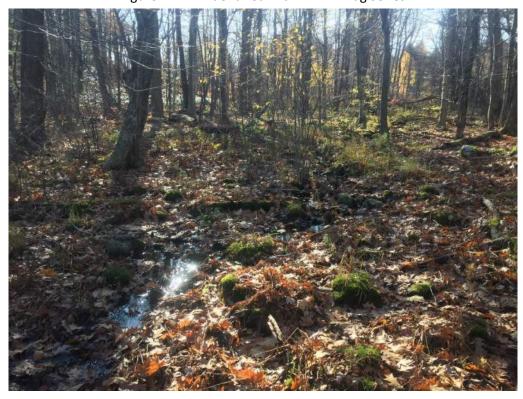
Figure 7: BVW Identified with BVW B Flag Series

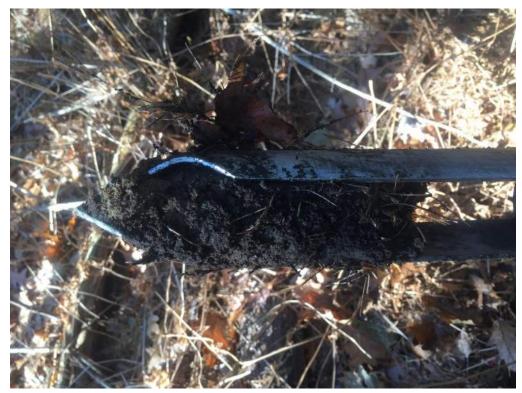
Figure 8: Wetland Soils Observed Onsite
