## STRUCTURES INSPECTION FIELD REPORT

BR. DEPT. NO.  
**P-02-003**

## SPECIAL MEMBER INSPECTION

CITY/TOWN <b>PAXTON</b>	8-STRUCTURE NO. <b>P02003-6UX-MUN-BRI</b>	11-Kilo. POINT <b>000.306</b>	90-ROUTINE INSP. DATE <b>Dec 3, 2021</b>	93*-SPEC. MEMB. INSP. DATE <b>Jun 21, 2023</b>
07-FACILITY CARRIED <b>HWY BLACK HILL R</b>	MEMORIAL NAME/LOCAL NAME	27-YR BUILT <b>1850</b>	106-YR REBUILT <b>1929</b>	*YR REHAB'D (NON 106) <b>0000</b>
06-FEATURES INTERSECTED <b>WATER TURKEY HILL BROOK</b>	26-FUNCTIONAL CLASS <b>Rural Local</b>	DIST. BRIDGE INSPECTION ENGINEER <b>M. Azizi</b>		
43-STRUCTURE TYPE <b>101 : Concrete Slab</b>	22-OWNER <b>Town Agency</b>	21-MAINTAINER <b>Town Agency</b>	TEAM LEADER <b>R. Rogers</b>	
107-DECK TYPE <b>1 : Concrete Cast-in-Place</b>	WEATHER <b>sunny</b>	TEMP. (air) <b>17°C</b>	TEAM MEMBERS <b>B. SANTEUFEMIO</b>

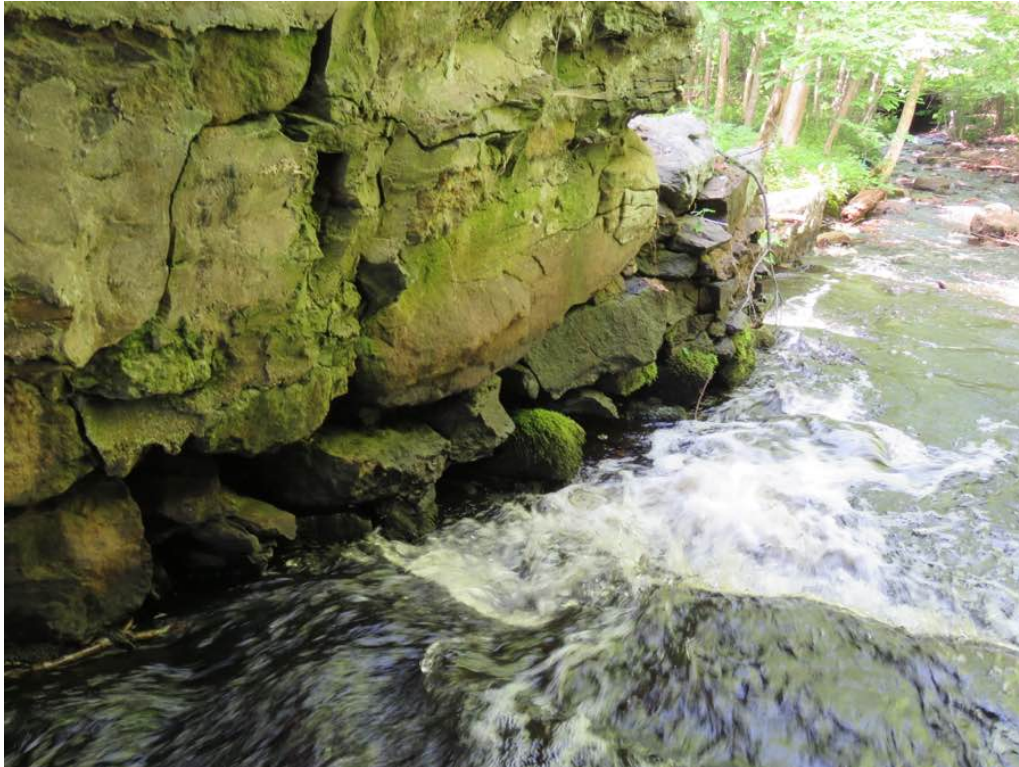
**Photo 5:** South breastwall, West end, voids to the bottom stones.

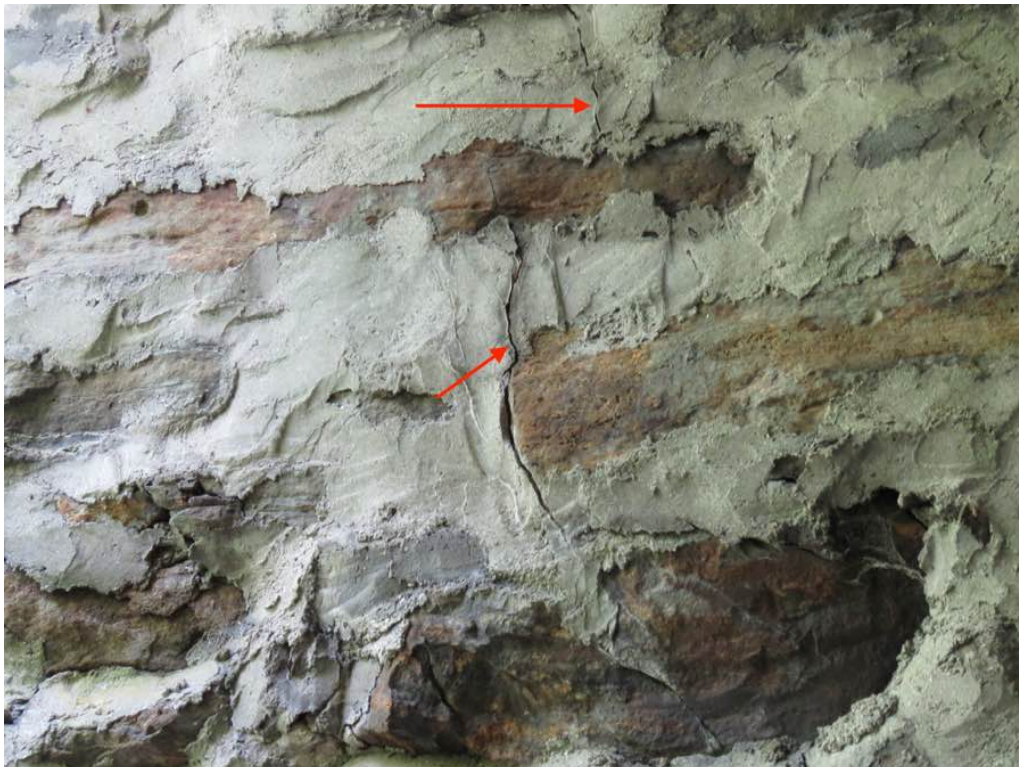
**Photo 6:** North breastwall, West end.

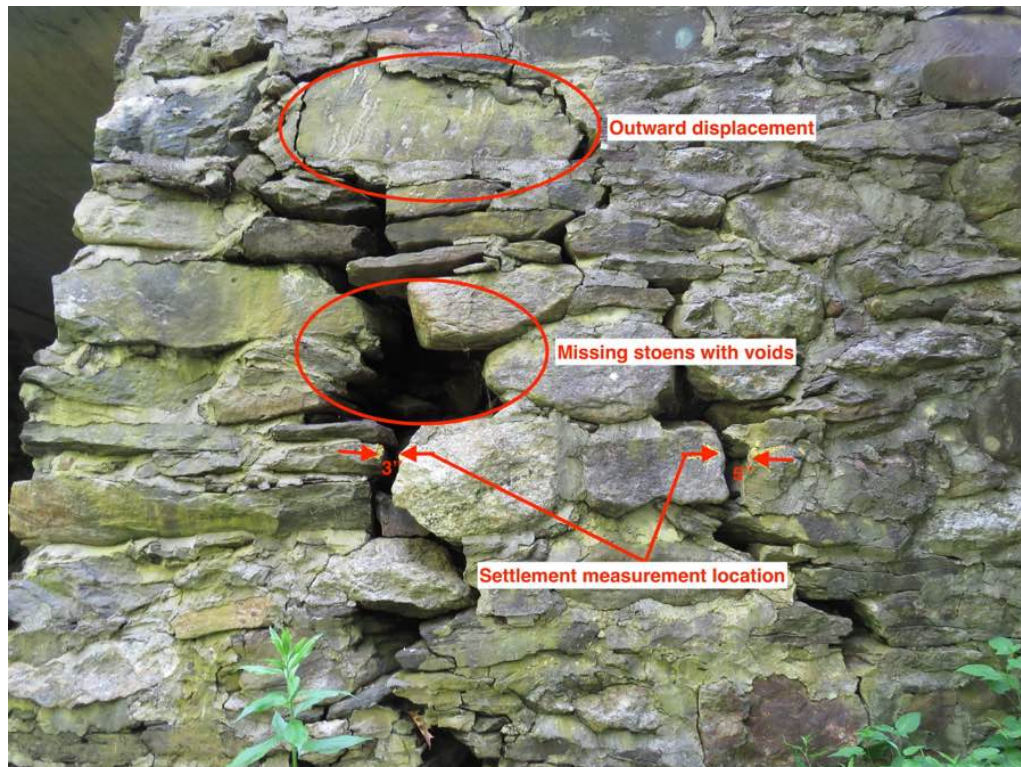
Photo 8: Southwest wingwall.

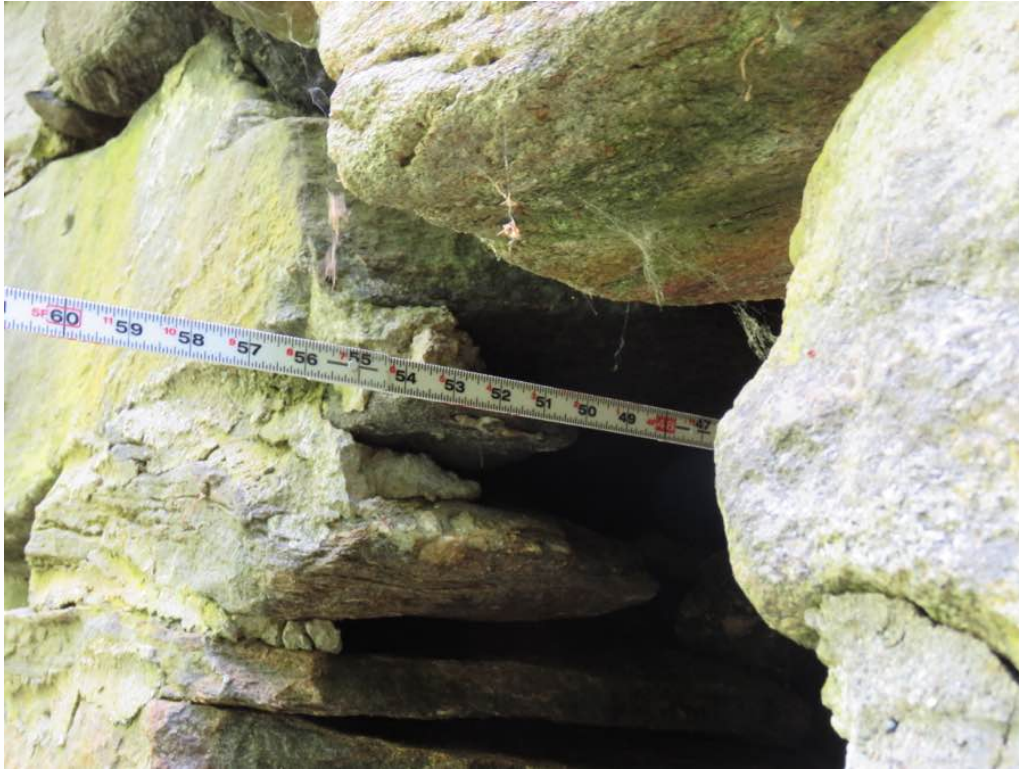
**Photo 9:** Penetration to the void on the Southwest wingwall.

- Adjacent to breastwall; there is significant settlement, measured at two areas of full height separation between the stones, i.e. 3.5 inch wide at the North separation and 3 inch wide at the South separation, with up to 52 inches of penetration. Measurement loci have been marked with yellow keel. **See photos #7 and #8.**
- At mid-height; missing stones with a void up to 1.83 foot wide x 2 foot high x 3 foot deep.
- Overall outward displacement; 3 inches, taken using a 4 foot level on previous measurement locus. **See photo #9.**

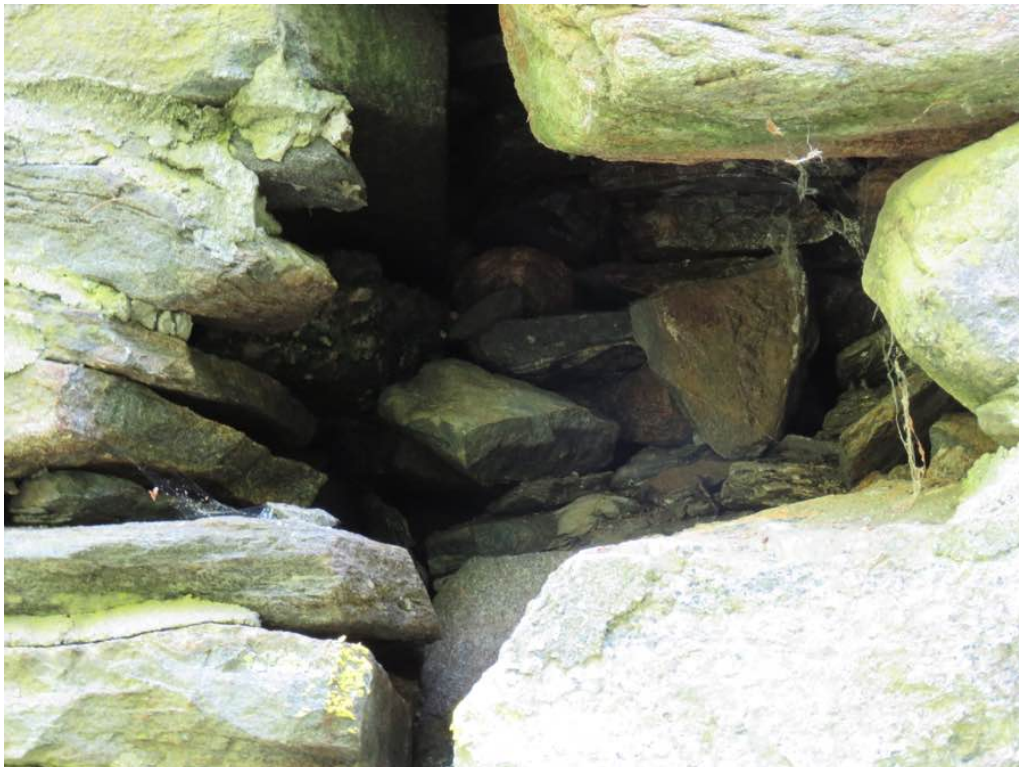
**Photo 10:** New loss of backfill and stones in the void.

There is a hole at the interface of the wearing surface and the wingwall at the joint. **See photo #10.**

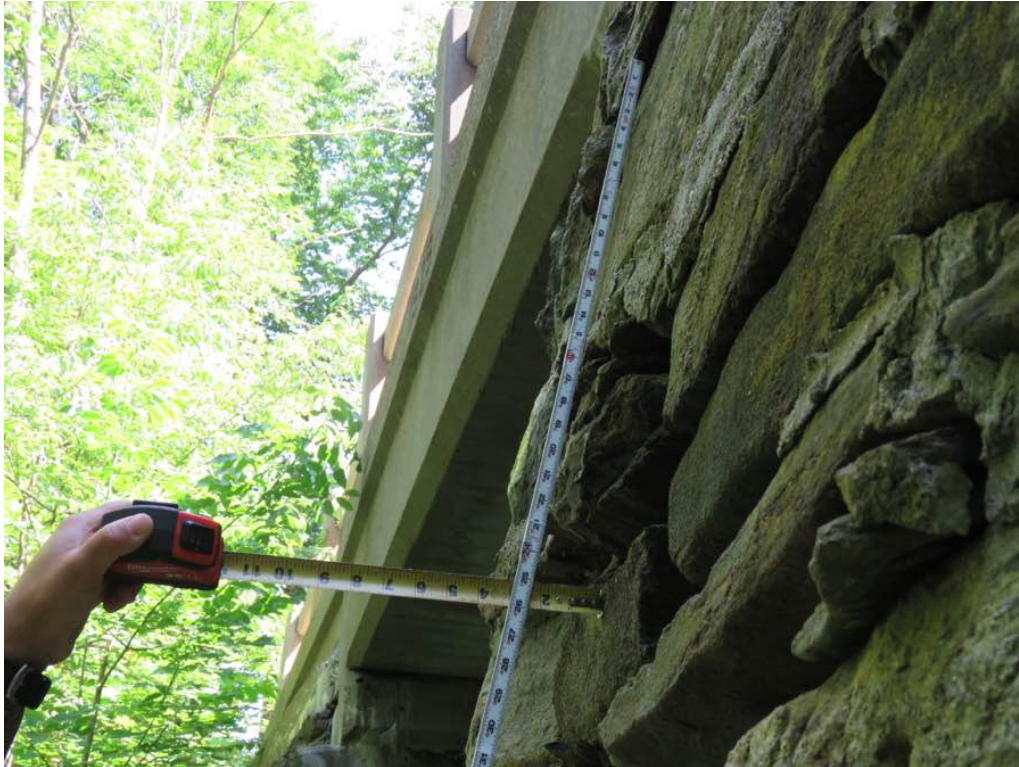
**Photo 11:** Outward displacement measurement to the Southwest wingwall.

- Wingwall top has 2 inches of outward displacement (measured at the concrete rail base) and a full height crack along the pointing. **See photo #11.**

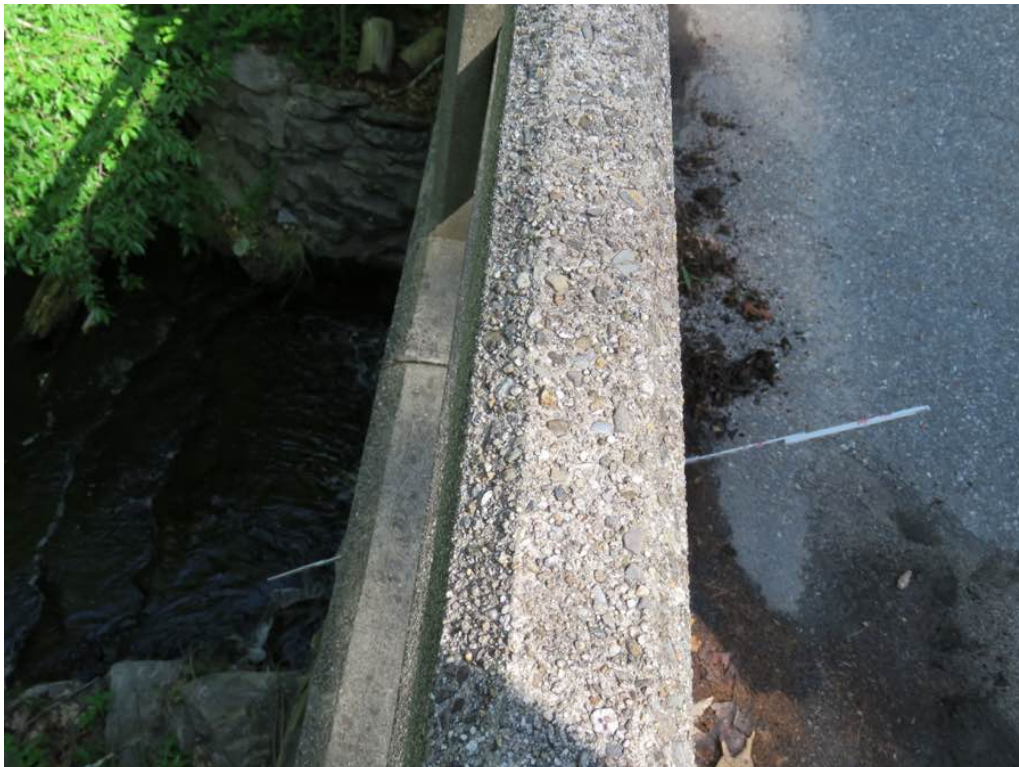
**Photo 12:** Hole at the interface joint.

There is a 2 inch space at the top between the wearing surface and the wingwall. **See photo #12.**

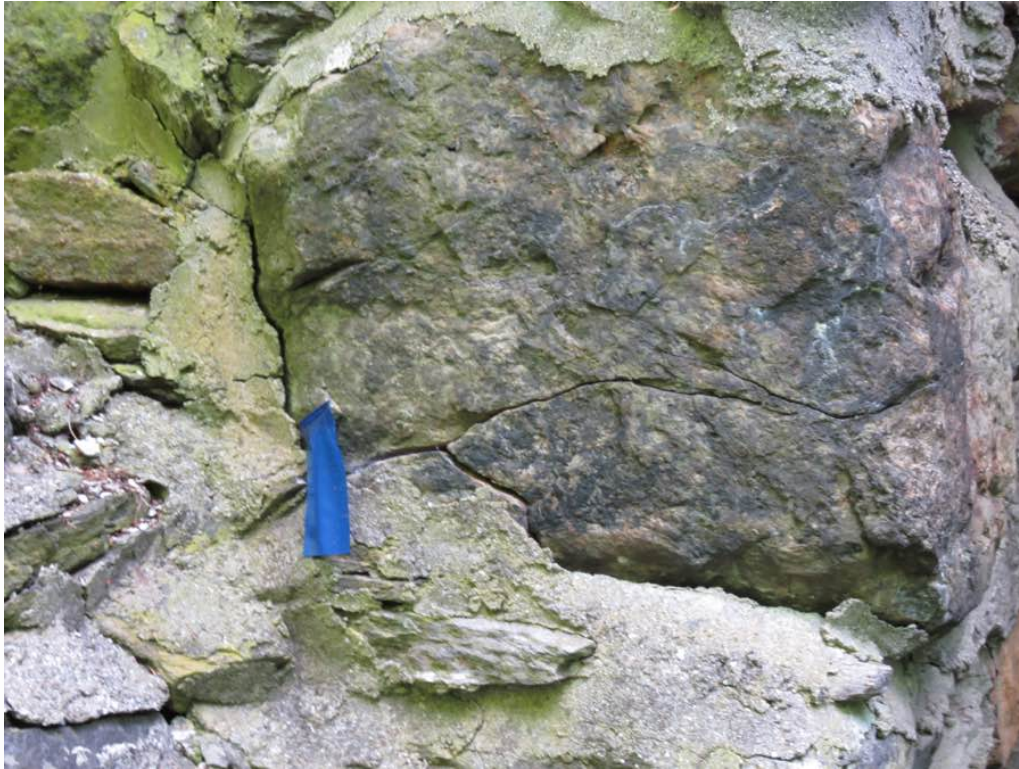
At wingwall/breastwall interface, cracked stone. **See photo 17.**

**Photo 17:** Northwest wingwall, breastwall interface.

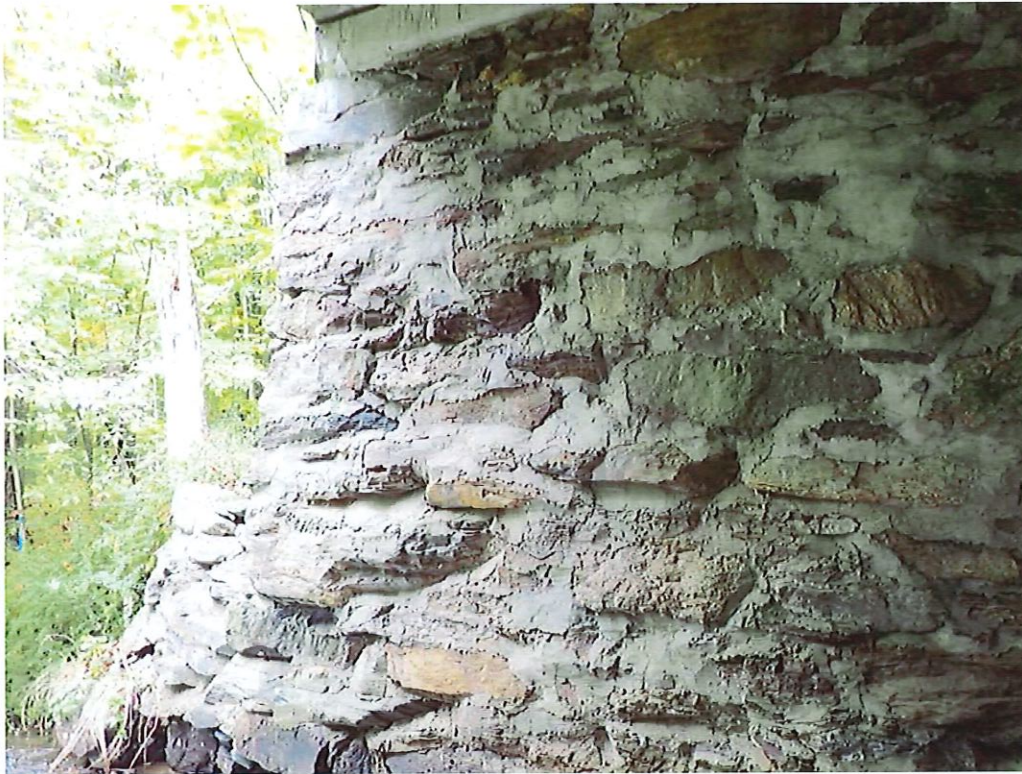
**Photo 3:** North breastwall west end, looking northwest.

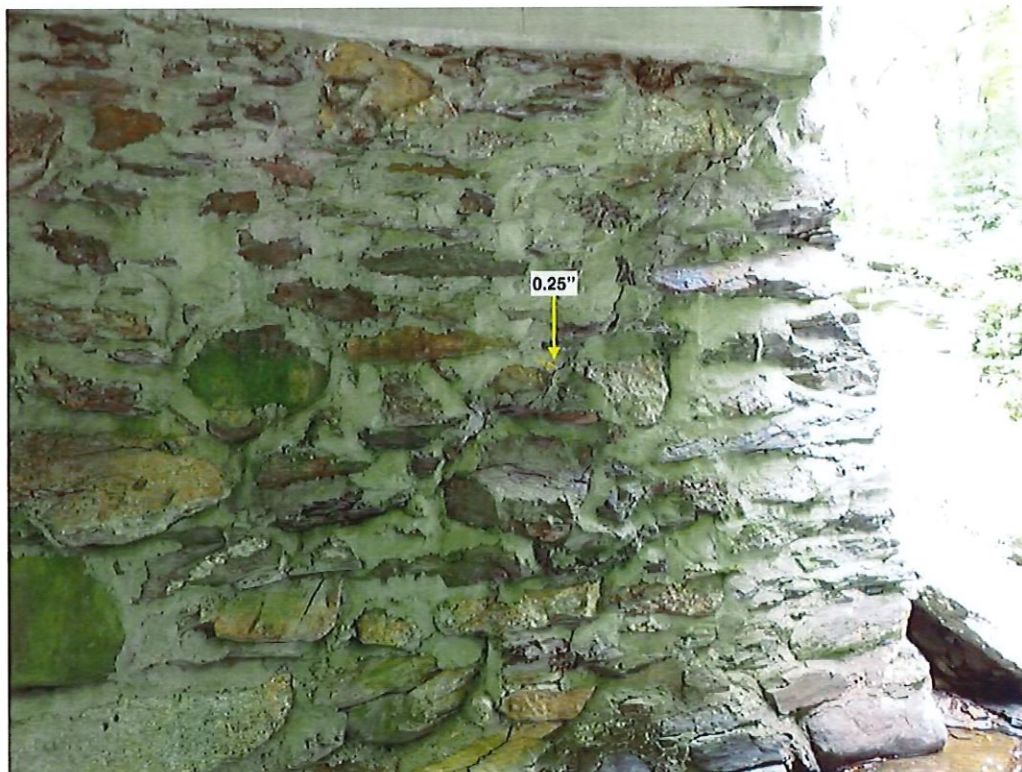
**Photo 4:** North breastwall east end, looking north.

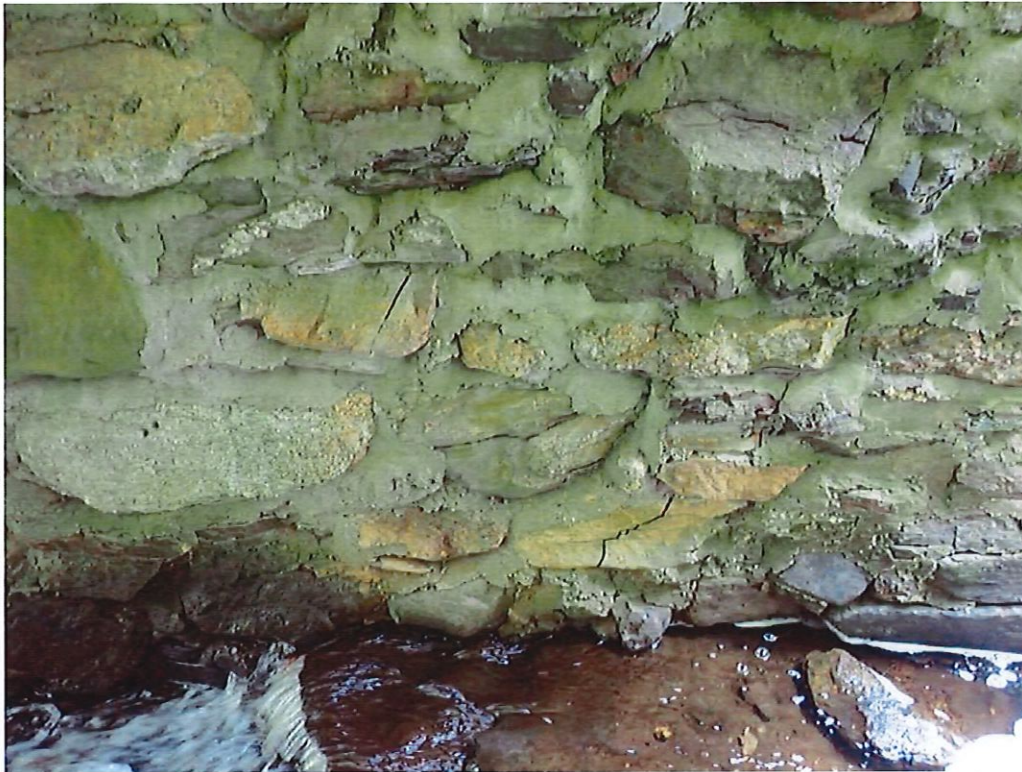
**Photo 5:** North breastwall east end bottom, looking north.

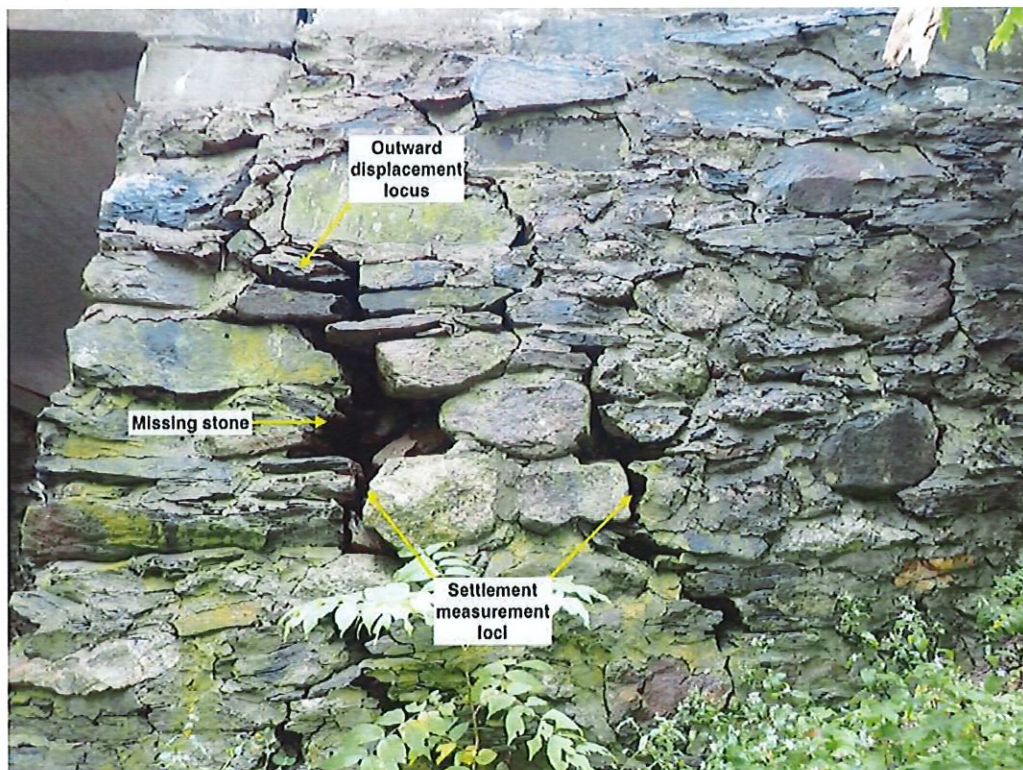
- Adjacent to breastwall; significant settlement, measured at two areas of full height separation between the stones, i.e. 3.5" wide at north separation and 3" wide at south separation, with up to 52" penetration. Measurement loci have been marked with yellow keel. **See Photo 6.**
- At mid-height; missing stone with a void up to 1.58' wide x 1' high x 1.5' deep.
- Outward displacement; 2".
- Overall outward displacement; 3", taken using a 4' level on previous measurement locus. **See Photo 7.**

**Photo 6:** Southwest wingwall, looking east.

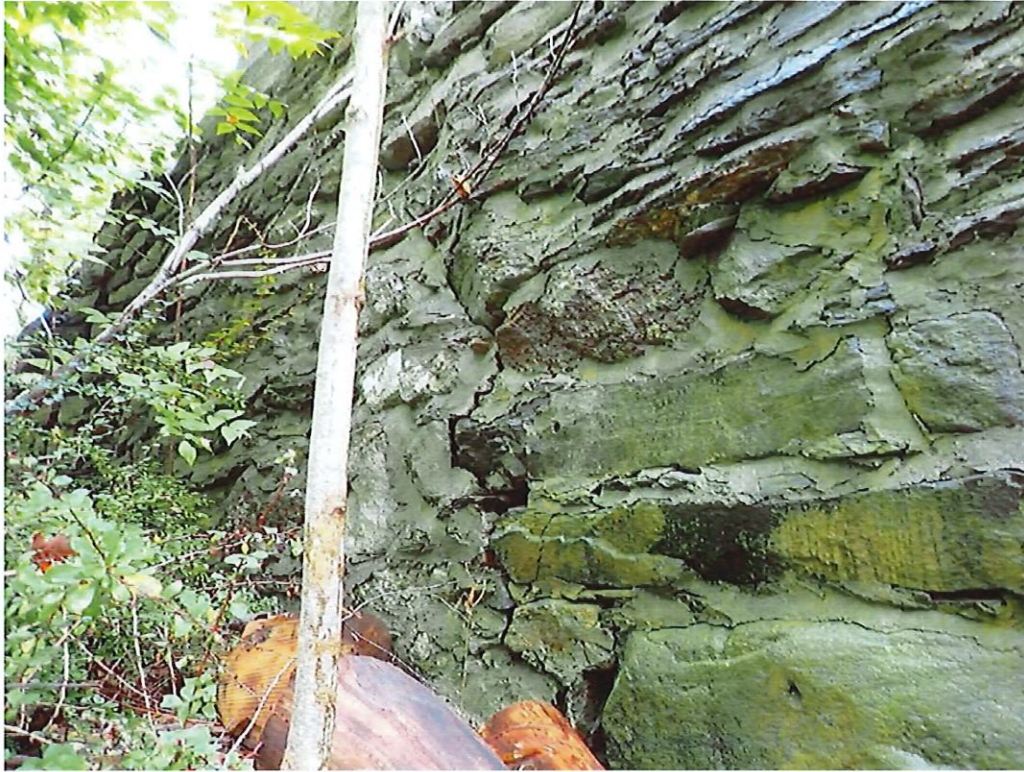
- Outward displacement; 1" with full height settlement crack (at pointing/stone interface). **See Photo 9.**
- At wingwall/breastwall interface; cracked stone. **See Photo 10.**

**Photo 9: Northwest wingwall, looking northeast.**

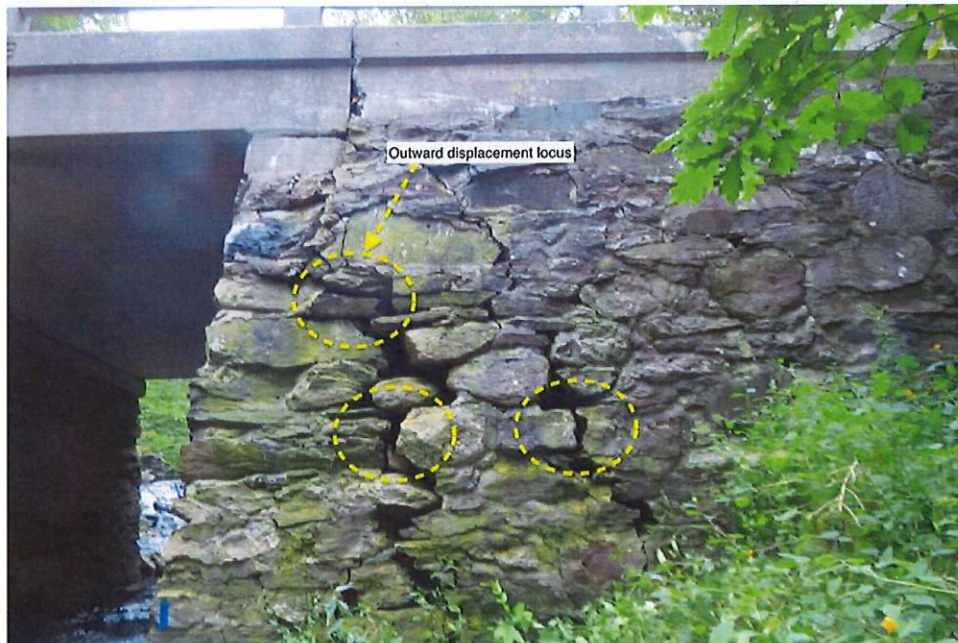
**Photo 5:** Southwest wingwall, settlement and measurement loci.

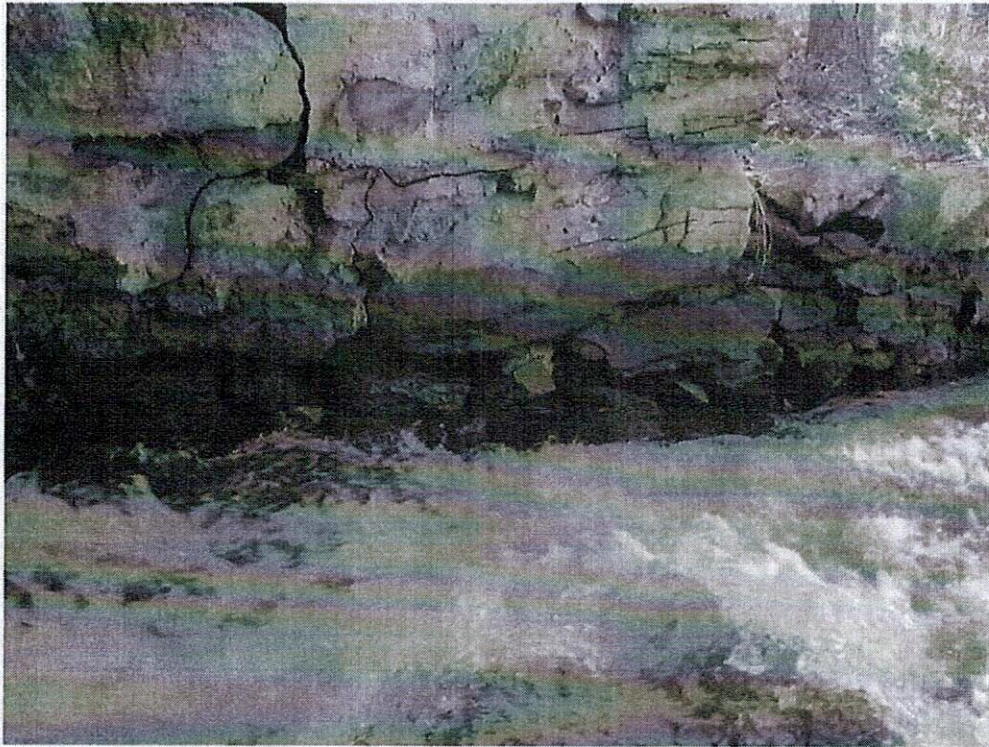
**Photo 3:** South breastwall, west end bottom.

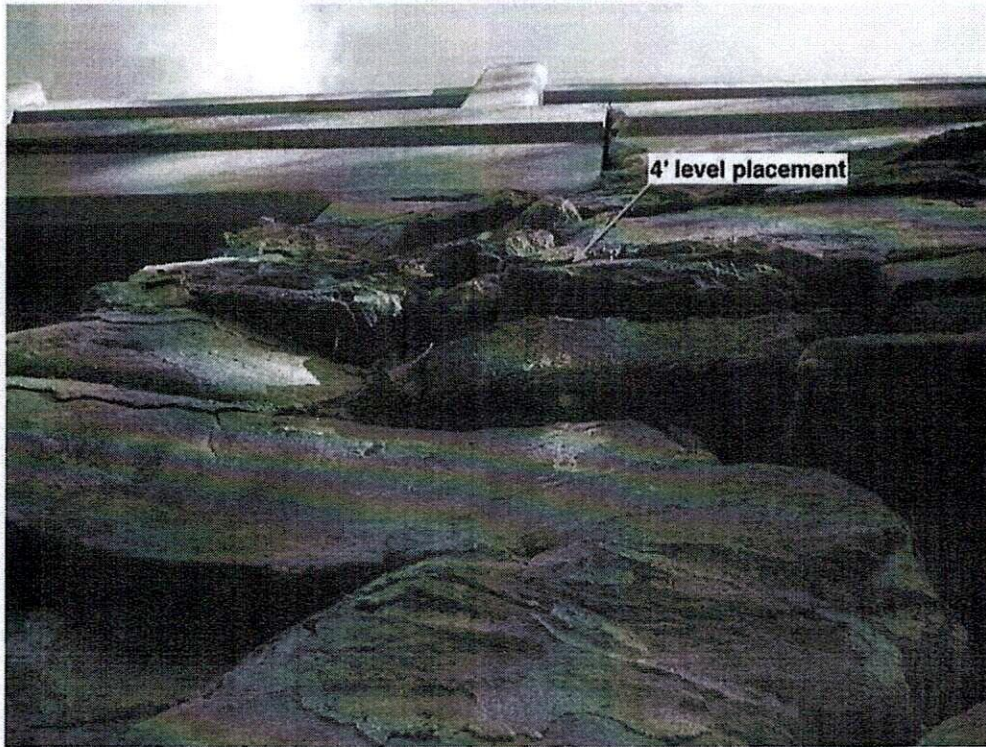
**Photo 6:** Southwest wingwall, outward displacement locus closeup.

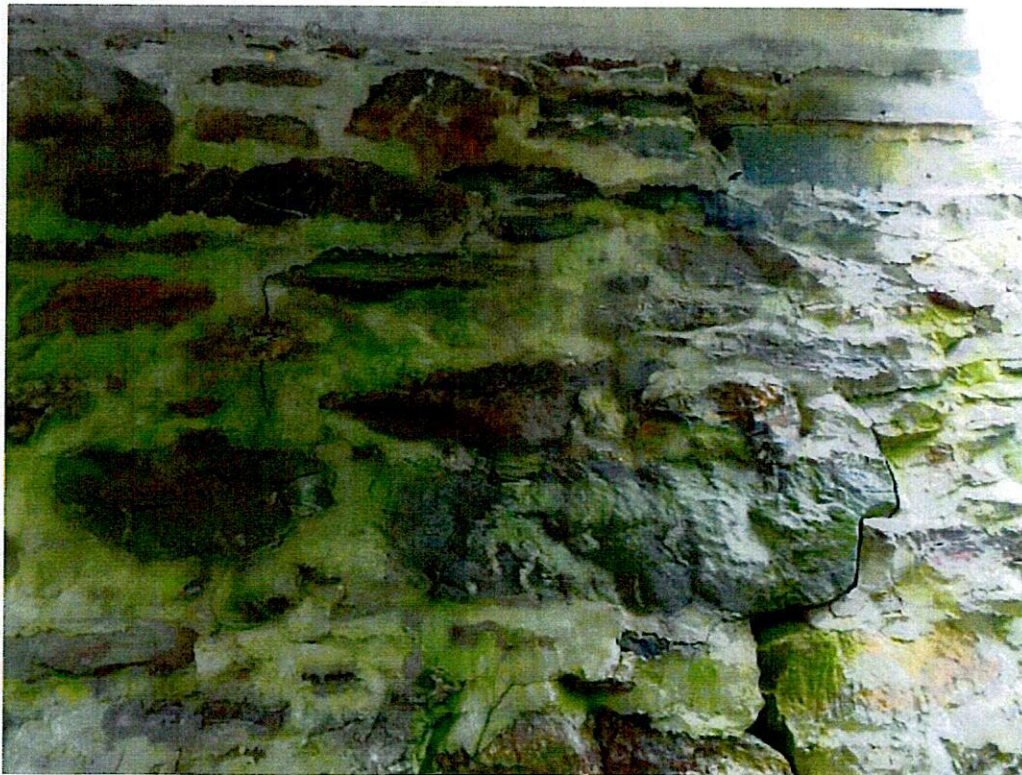
Photo 2: Top of the breastwall, Southwest corner.

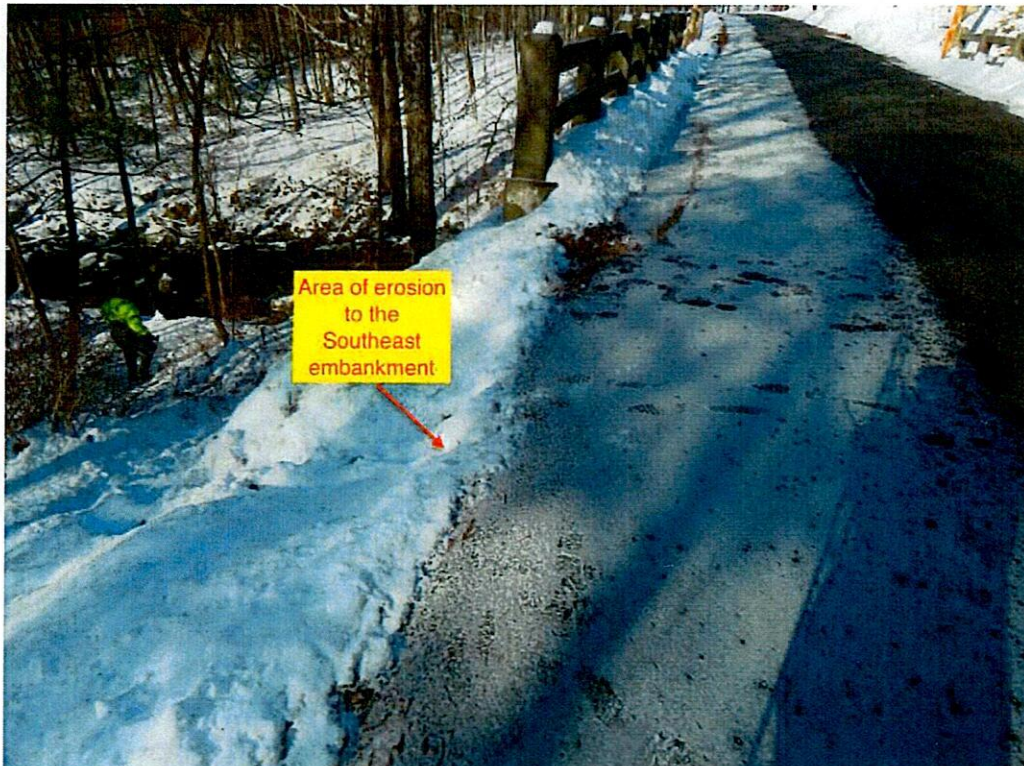
There is minor to moderate erosion to the Southeast and Northwest approach embankments. **See photos #11 and #12.** The full extent of the erosion was hidden by the snow.

Photo 12: Area of erosion to the Southeast embankment.
